## **Conservation Commission AGENDA**

TOWN OF AGAWAM  
ADAMS STREET

ADAMS ST CULVERT REPLACEMENT  
TOWN OF AGAWAM  
ADAMS STREET  
OVER THREE MILE BROOK

**Re: Notice of Intent Application**  
**Adams Street Over Three Mile Brook Culvert Replacement**  
**Agawam, Massachusetts**

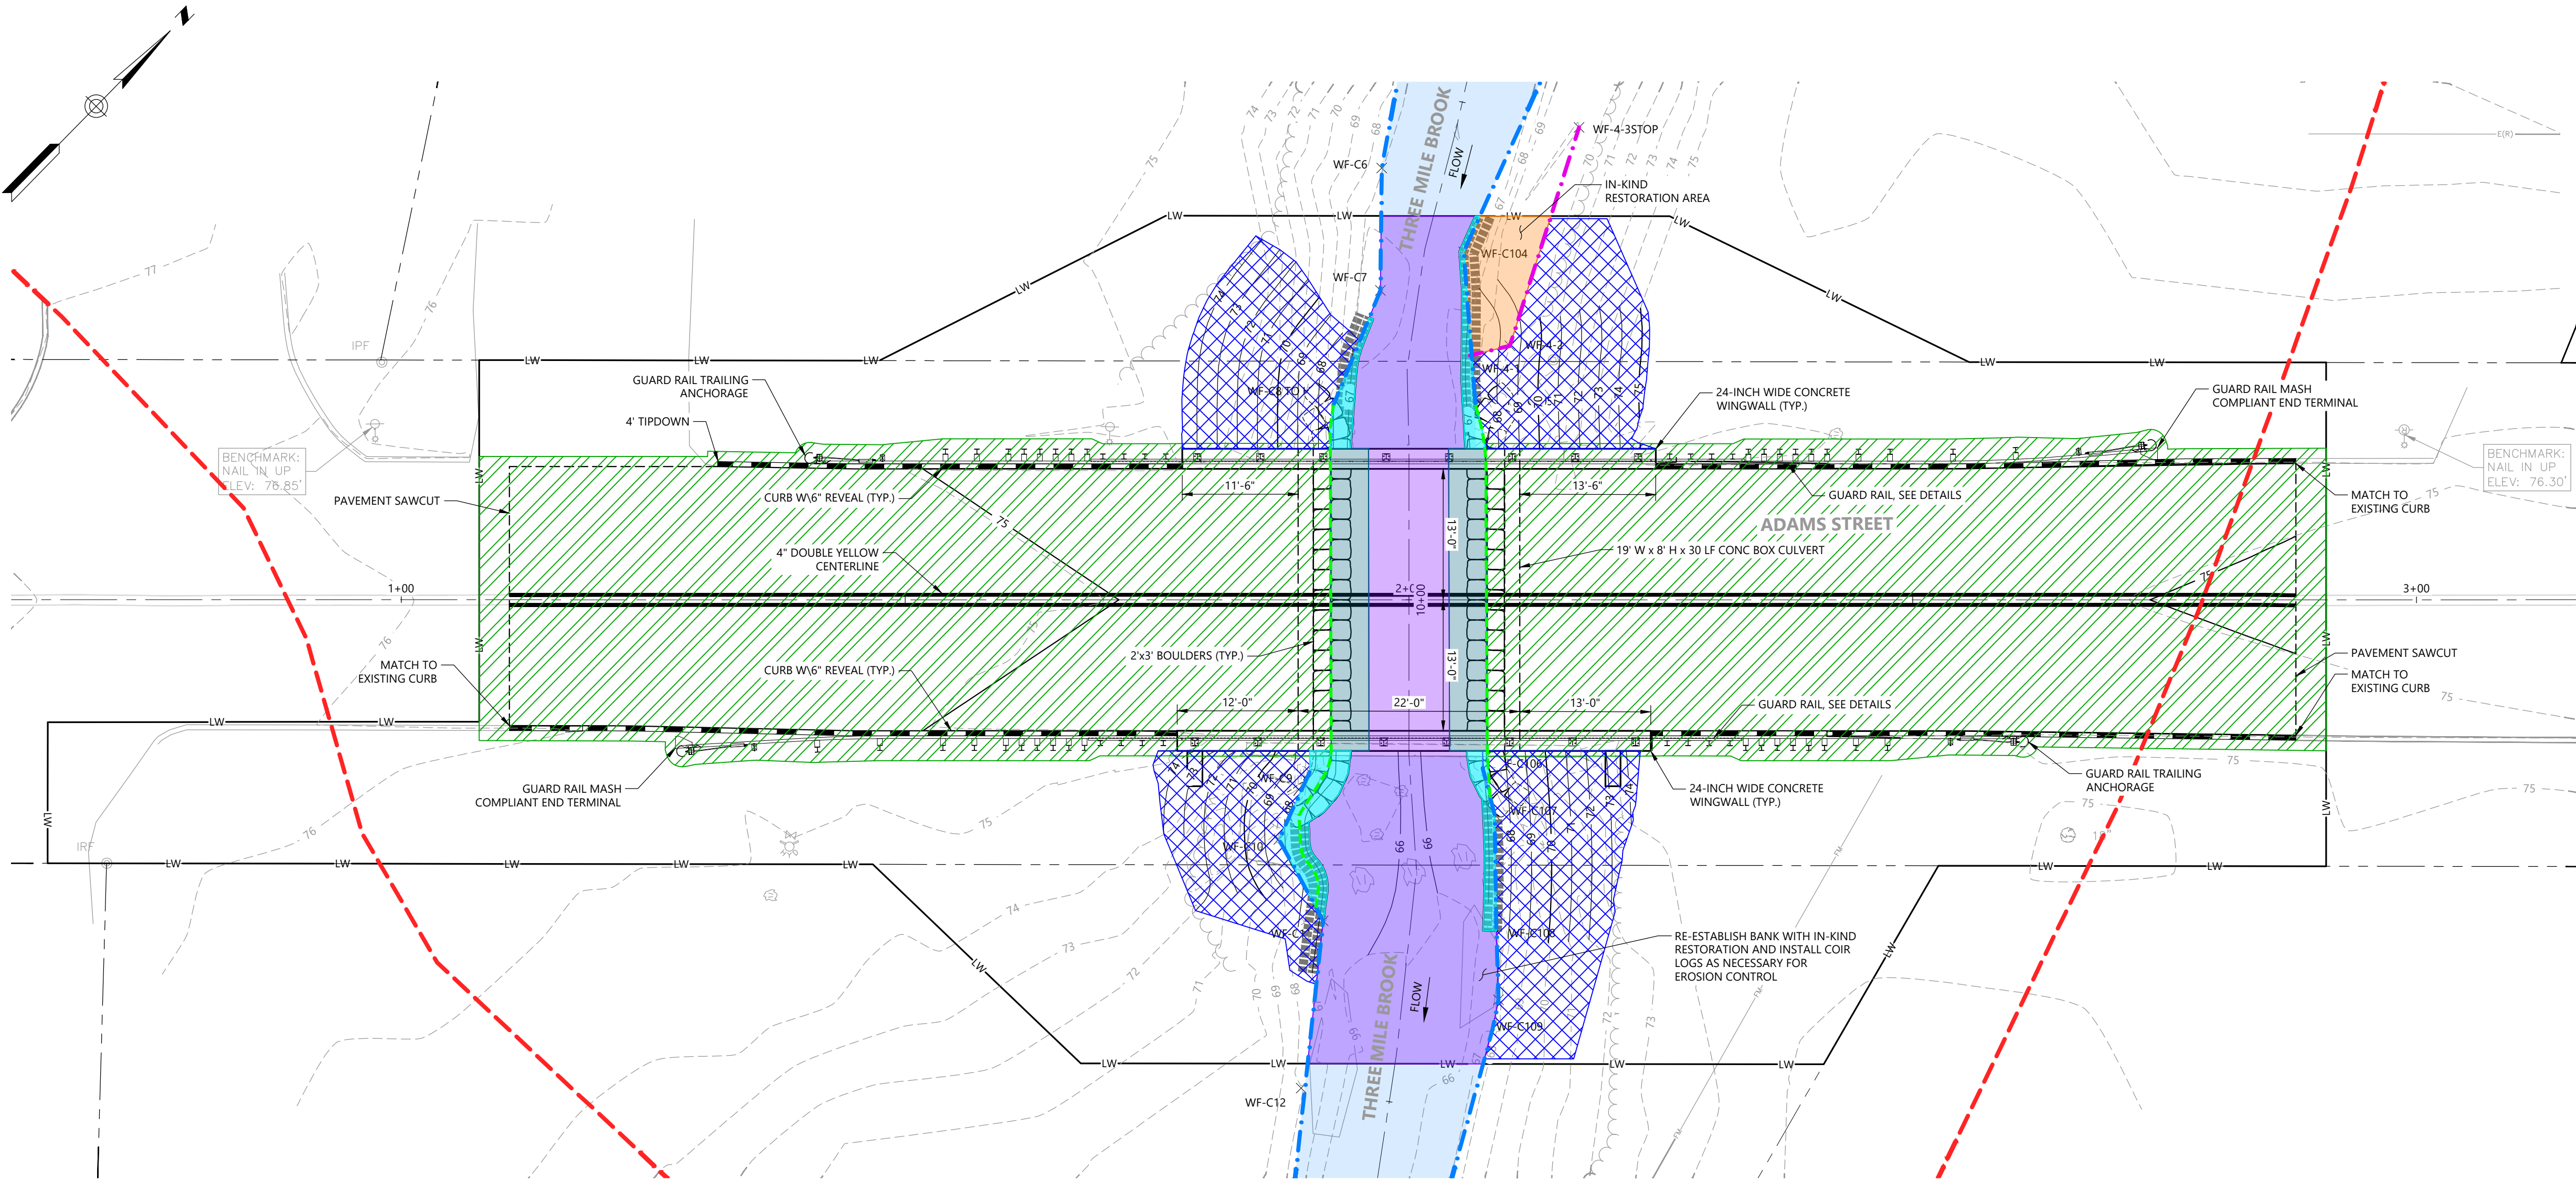
FIGURE 1 - RESOURCE AREAS

RESOURCE AREA PLAN  
SCALE: 1" = 10'

- BORDERING LAND SUBJECT TO FLOODING (100-YEAR FLOOD ZONE, DEFINED BY FEMA)
- BORDERING VEGETATED WETLAND
- BANK MEAN ANNUAL HIGH WATER LINE
- BANK/ORDINARY HIGH WATER CREATED
- LAND BELOW ORDINARY HIGH WATER/BANK
- TEMPORARY BORDERING VEGETATED WETLAND IMPACTS
- TEMPORARY LAND UNDER WATER BODIES & WATERWAYS IMPACTS
- PERMANENT LAND UNDER WATER BODIES & WATERWAYS IMPACTS
- LAND UNDER WATER BODIES & WATERWAYS CREATED
- TEMPORARY RIVERFRONT AREA IMPACTS
- PERMANENT RIVERFRONT AREA IMPACTS

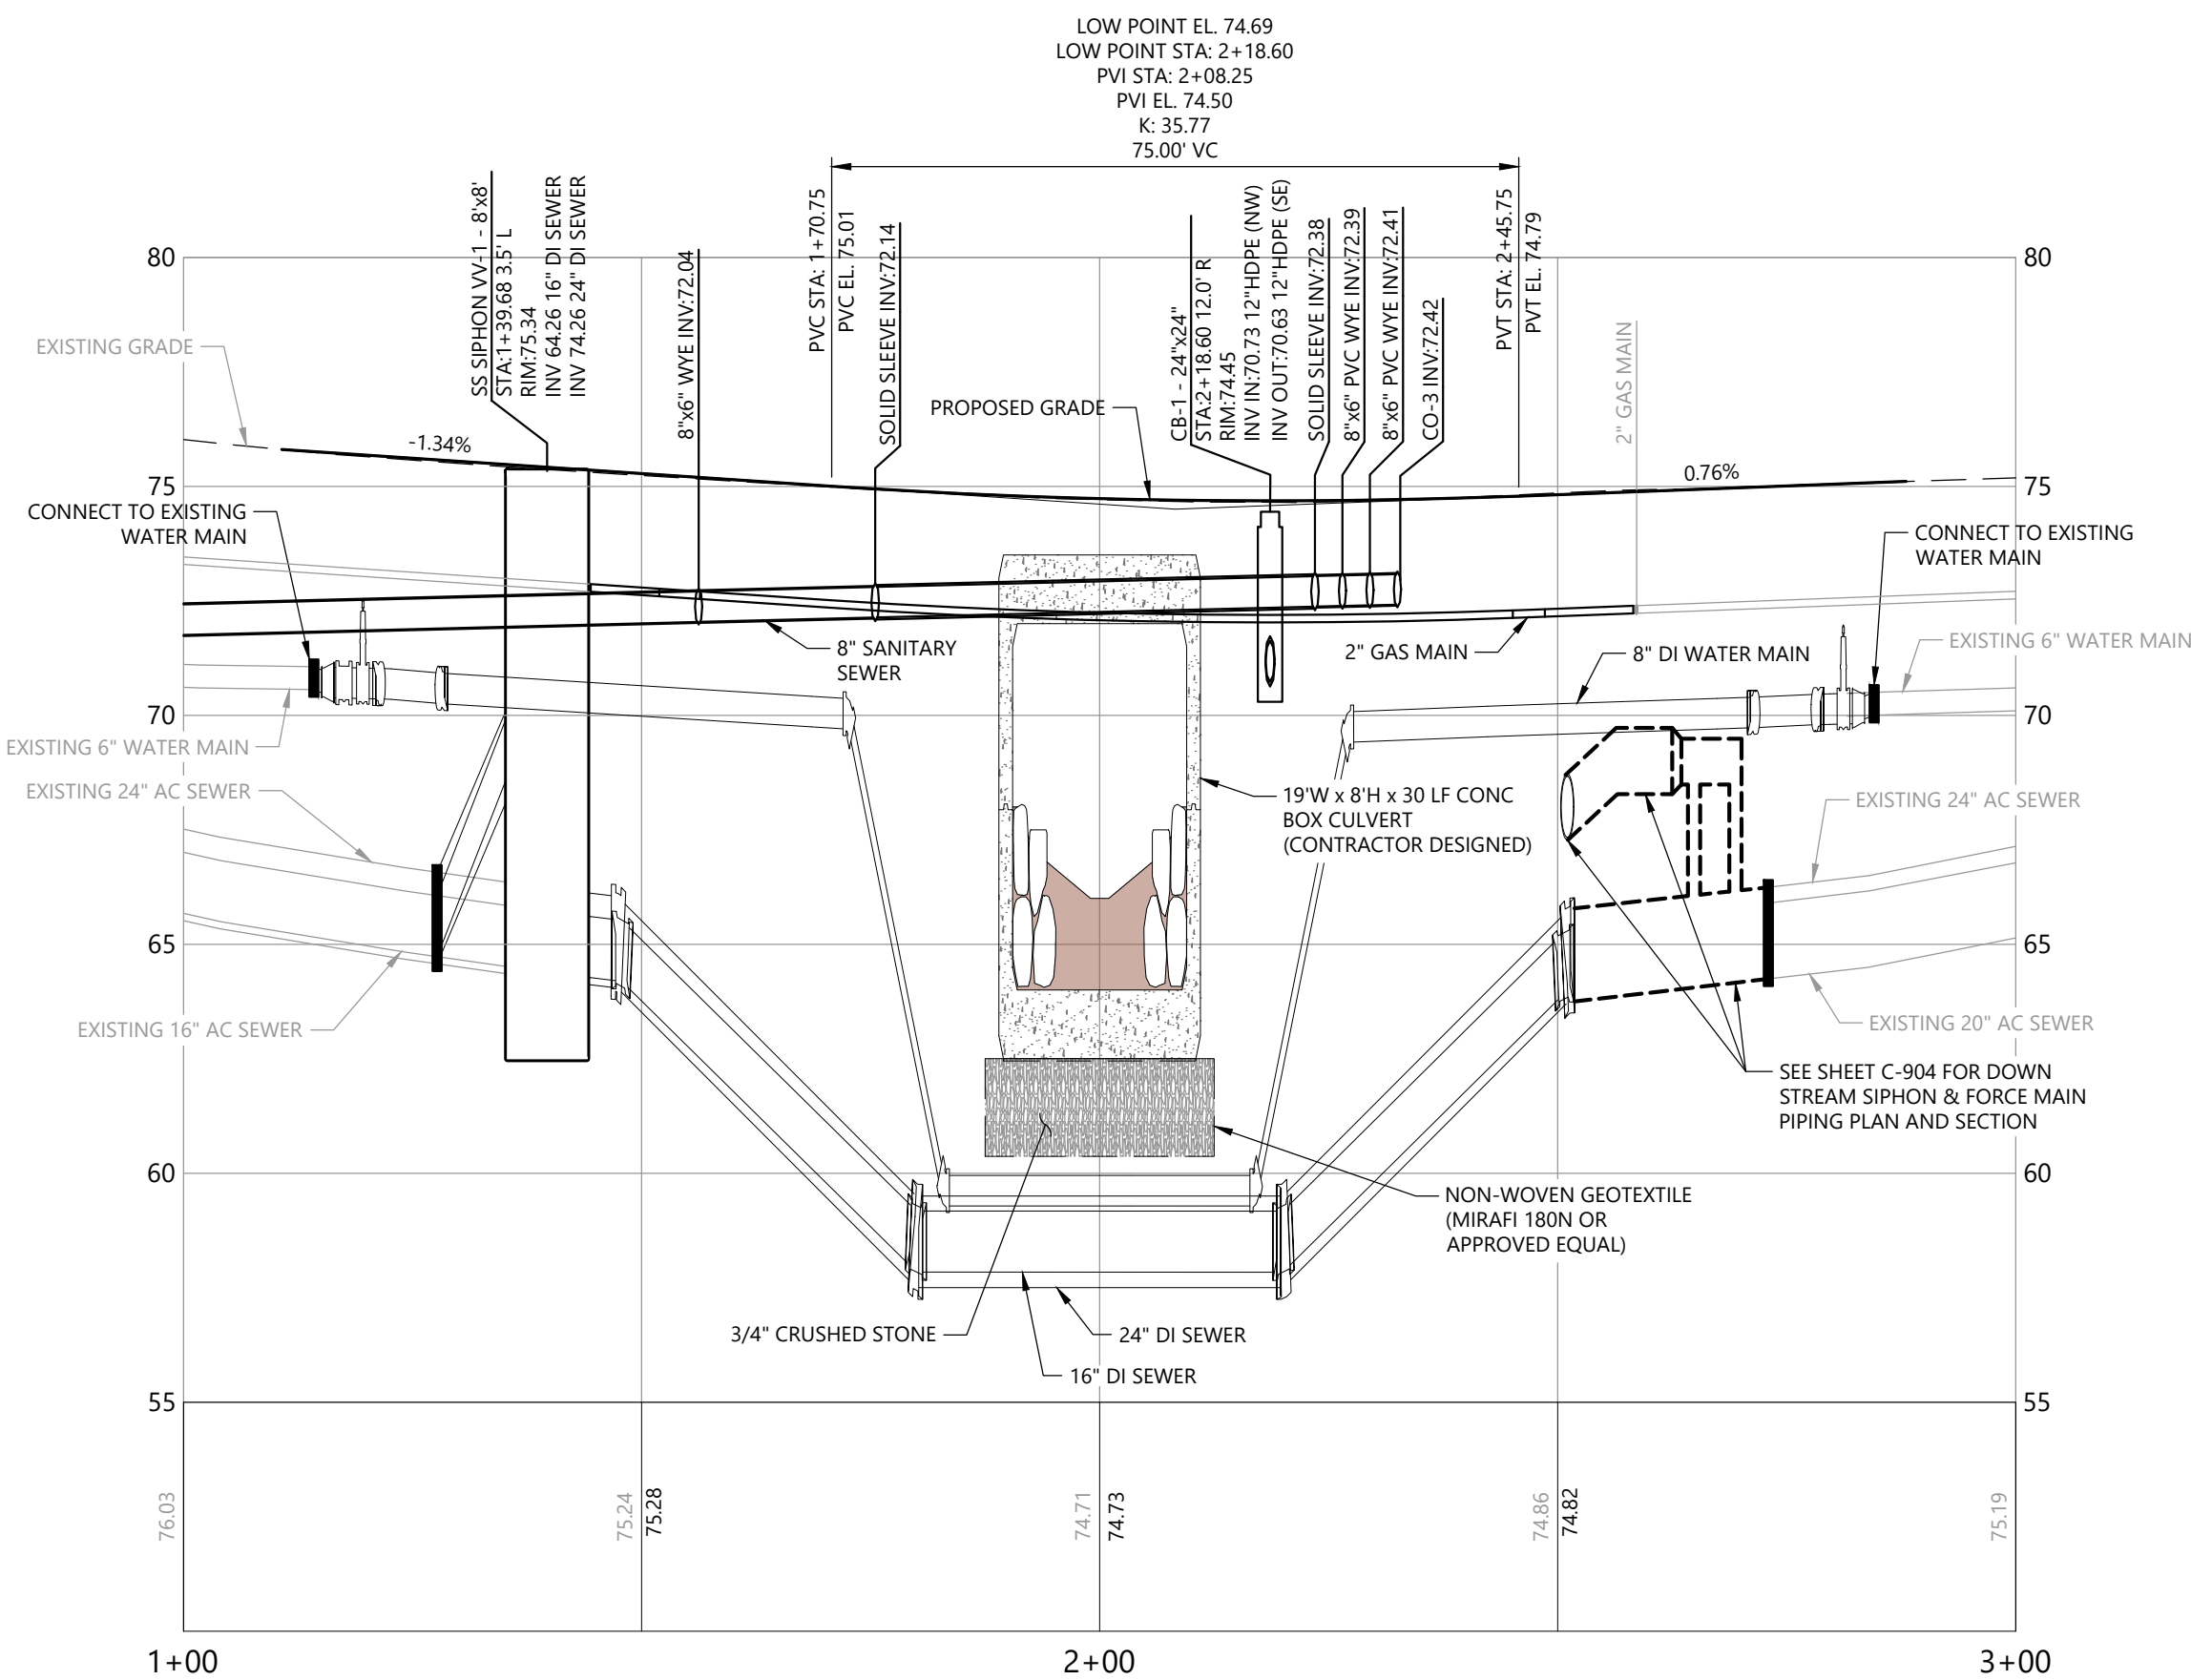
ADAMS STREET PROFILE STA. 1+00 TO STA. 3+00  
HORIZONTAL SCALE: 1" = 20'  
VERTICAL SCALE: 1" = 4'

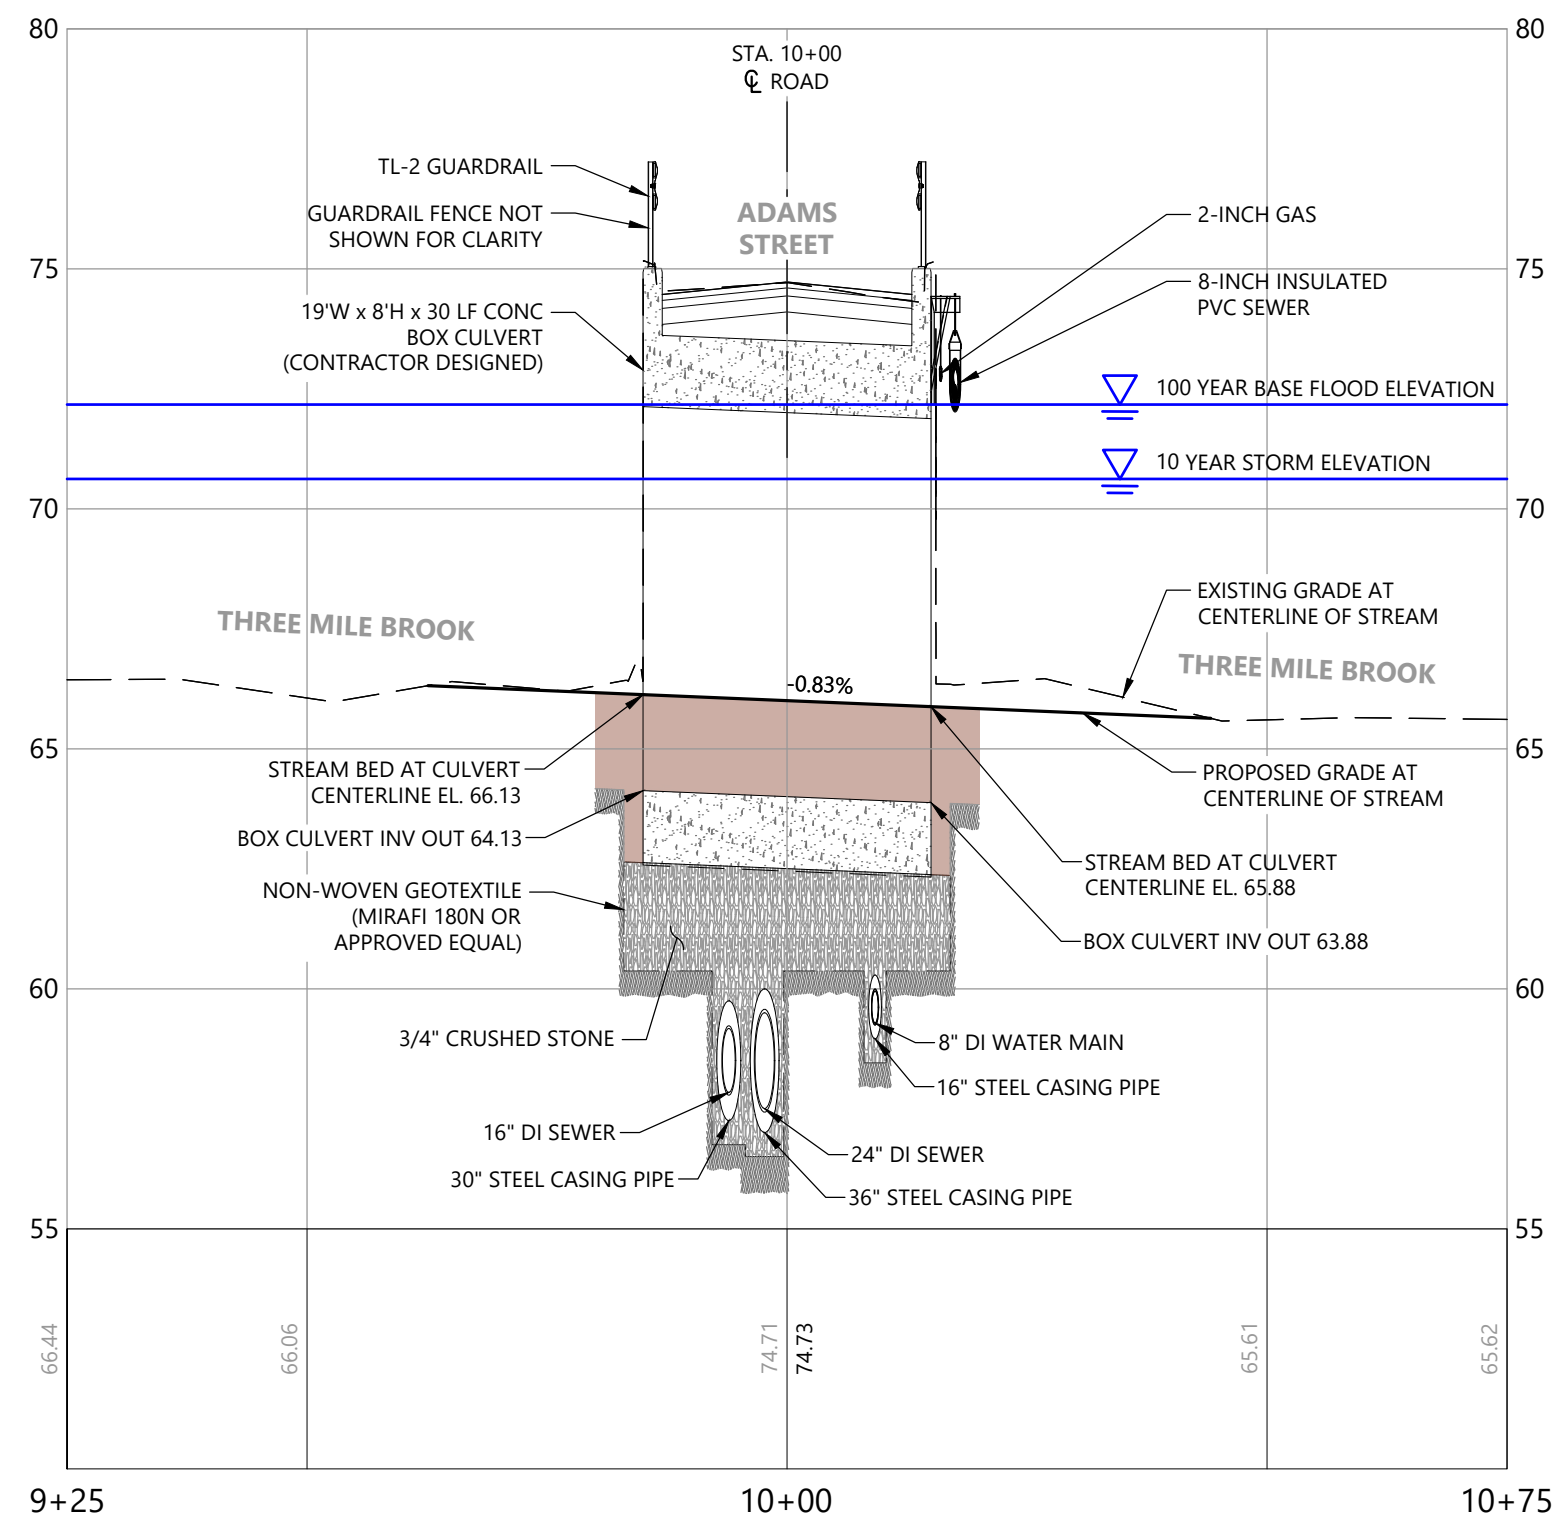
THREE MILE BROOK PROFILE STA. 9+25 TO STA. 10+75  
HORIZONTAL SCALE: 1" = 20'  
VERTICAL SCALE: 1" = 4'

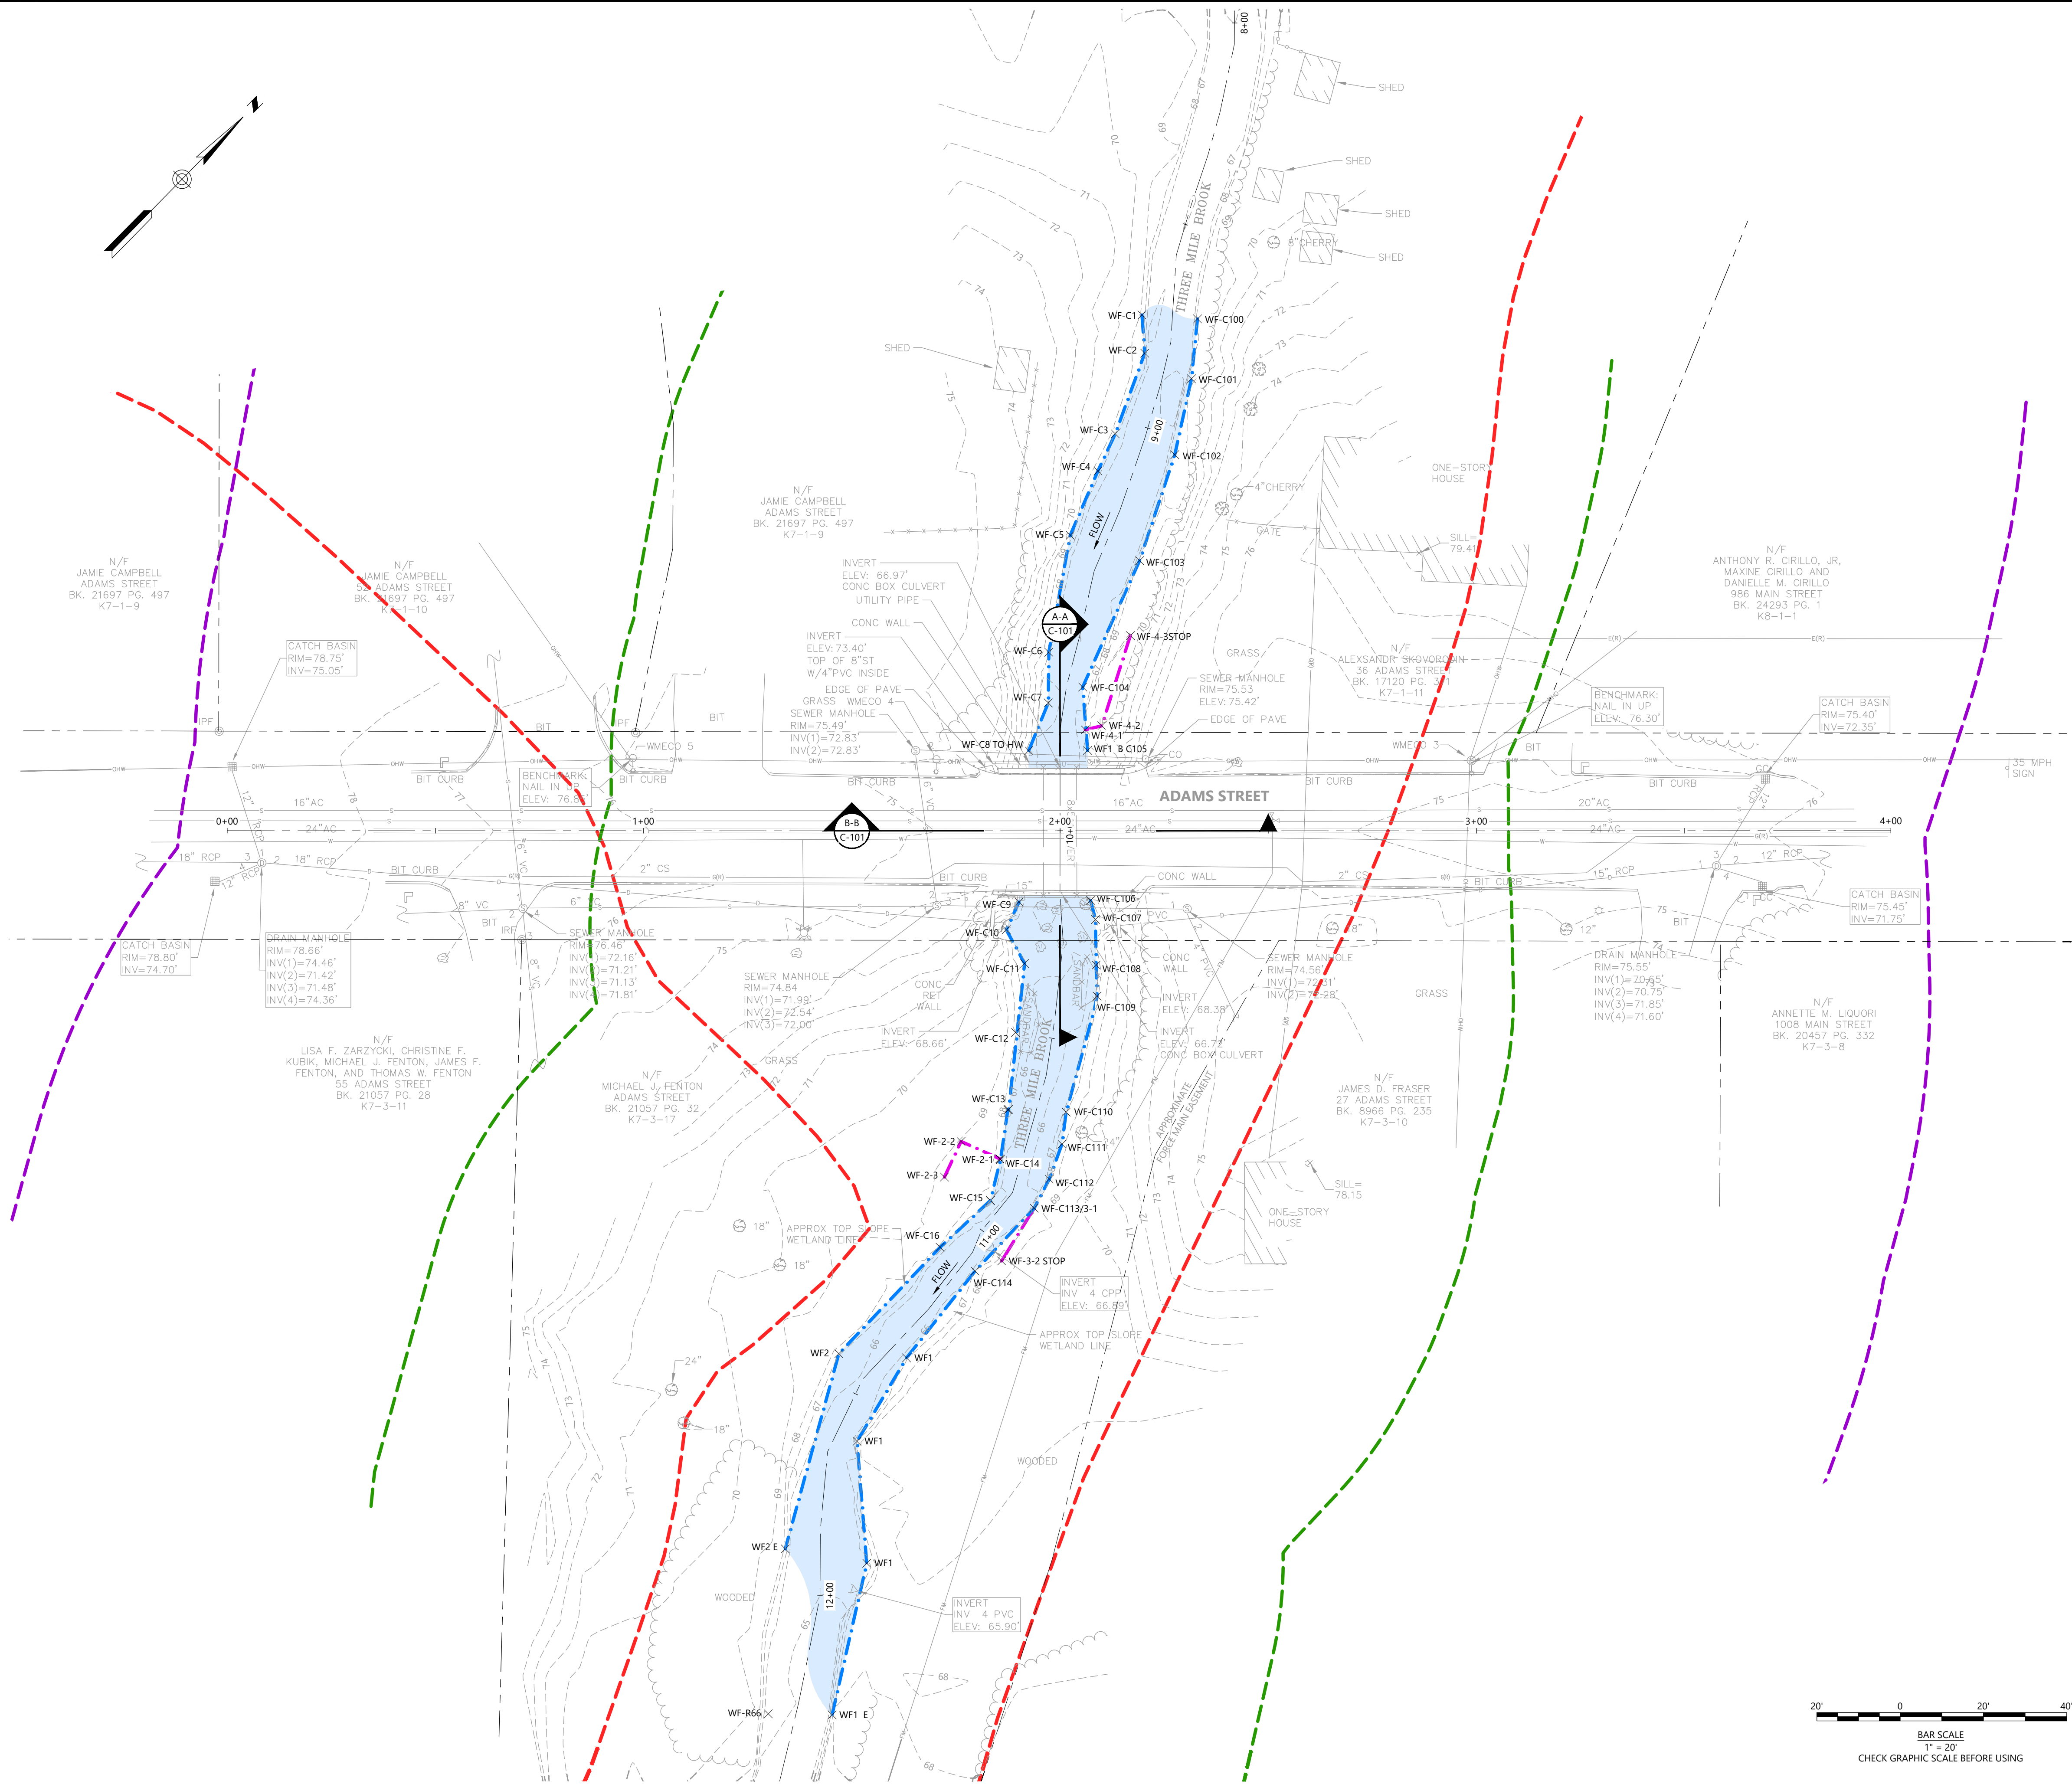
C-100 - EXISTING CONDITIONS PLAN

EXISTING CONDITIONS PLAN  
SCALE: 1" = 20'

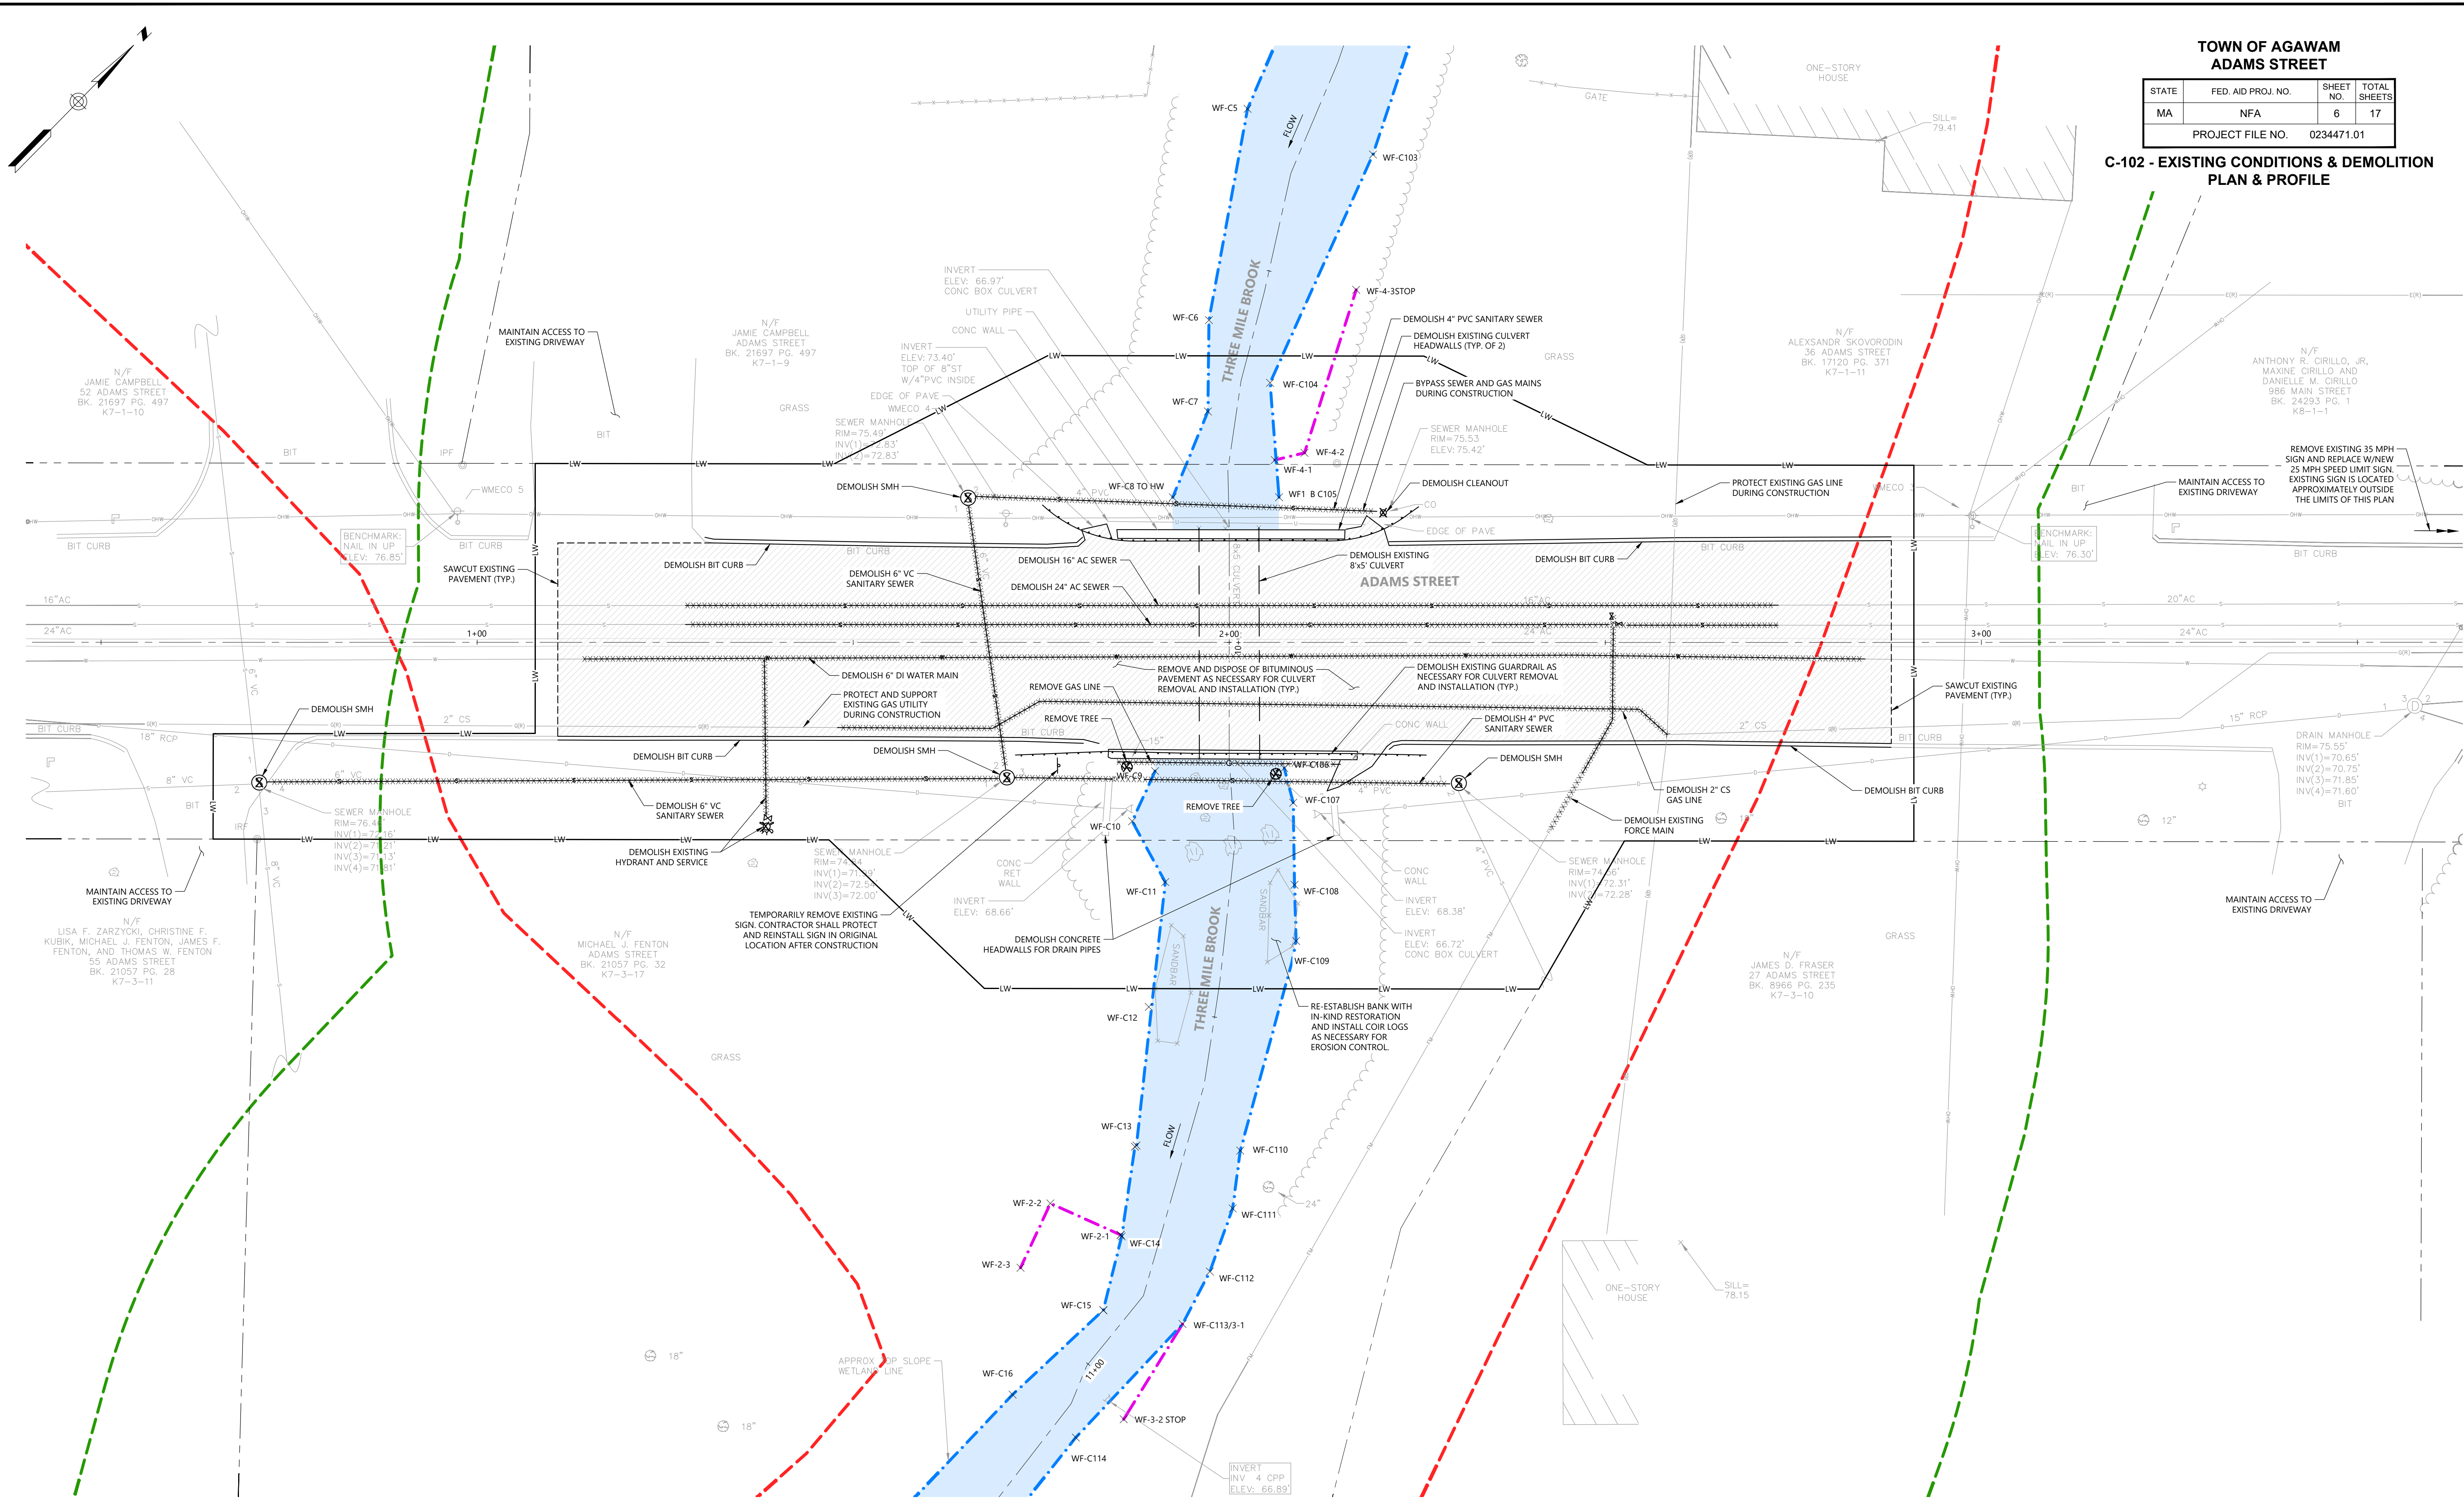
C-102 - EXISTING CONDITIONS & DEMOLITION  
PLAN & PROFILE

DEMOLITION AND EROSION CONTROL PLAN

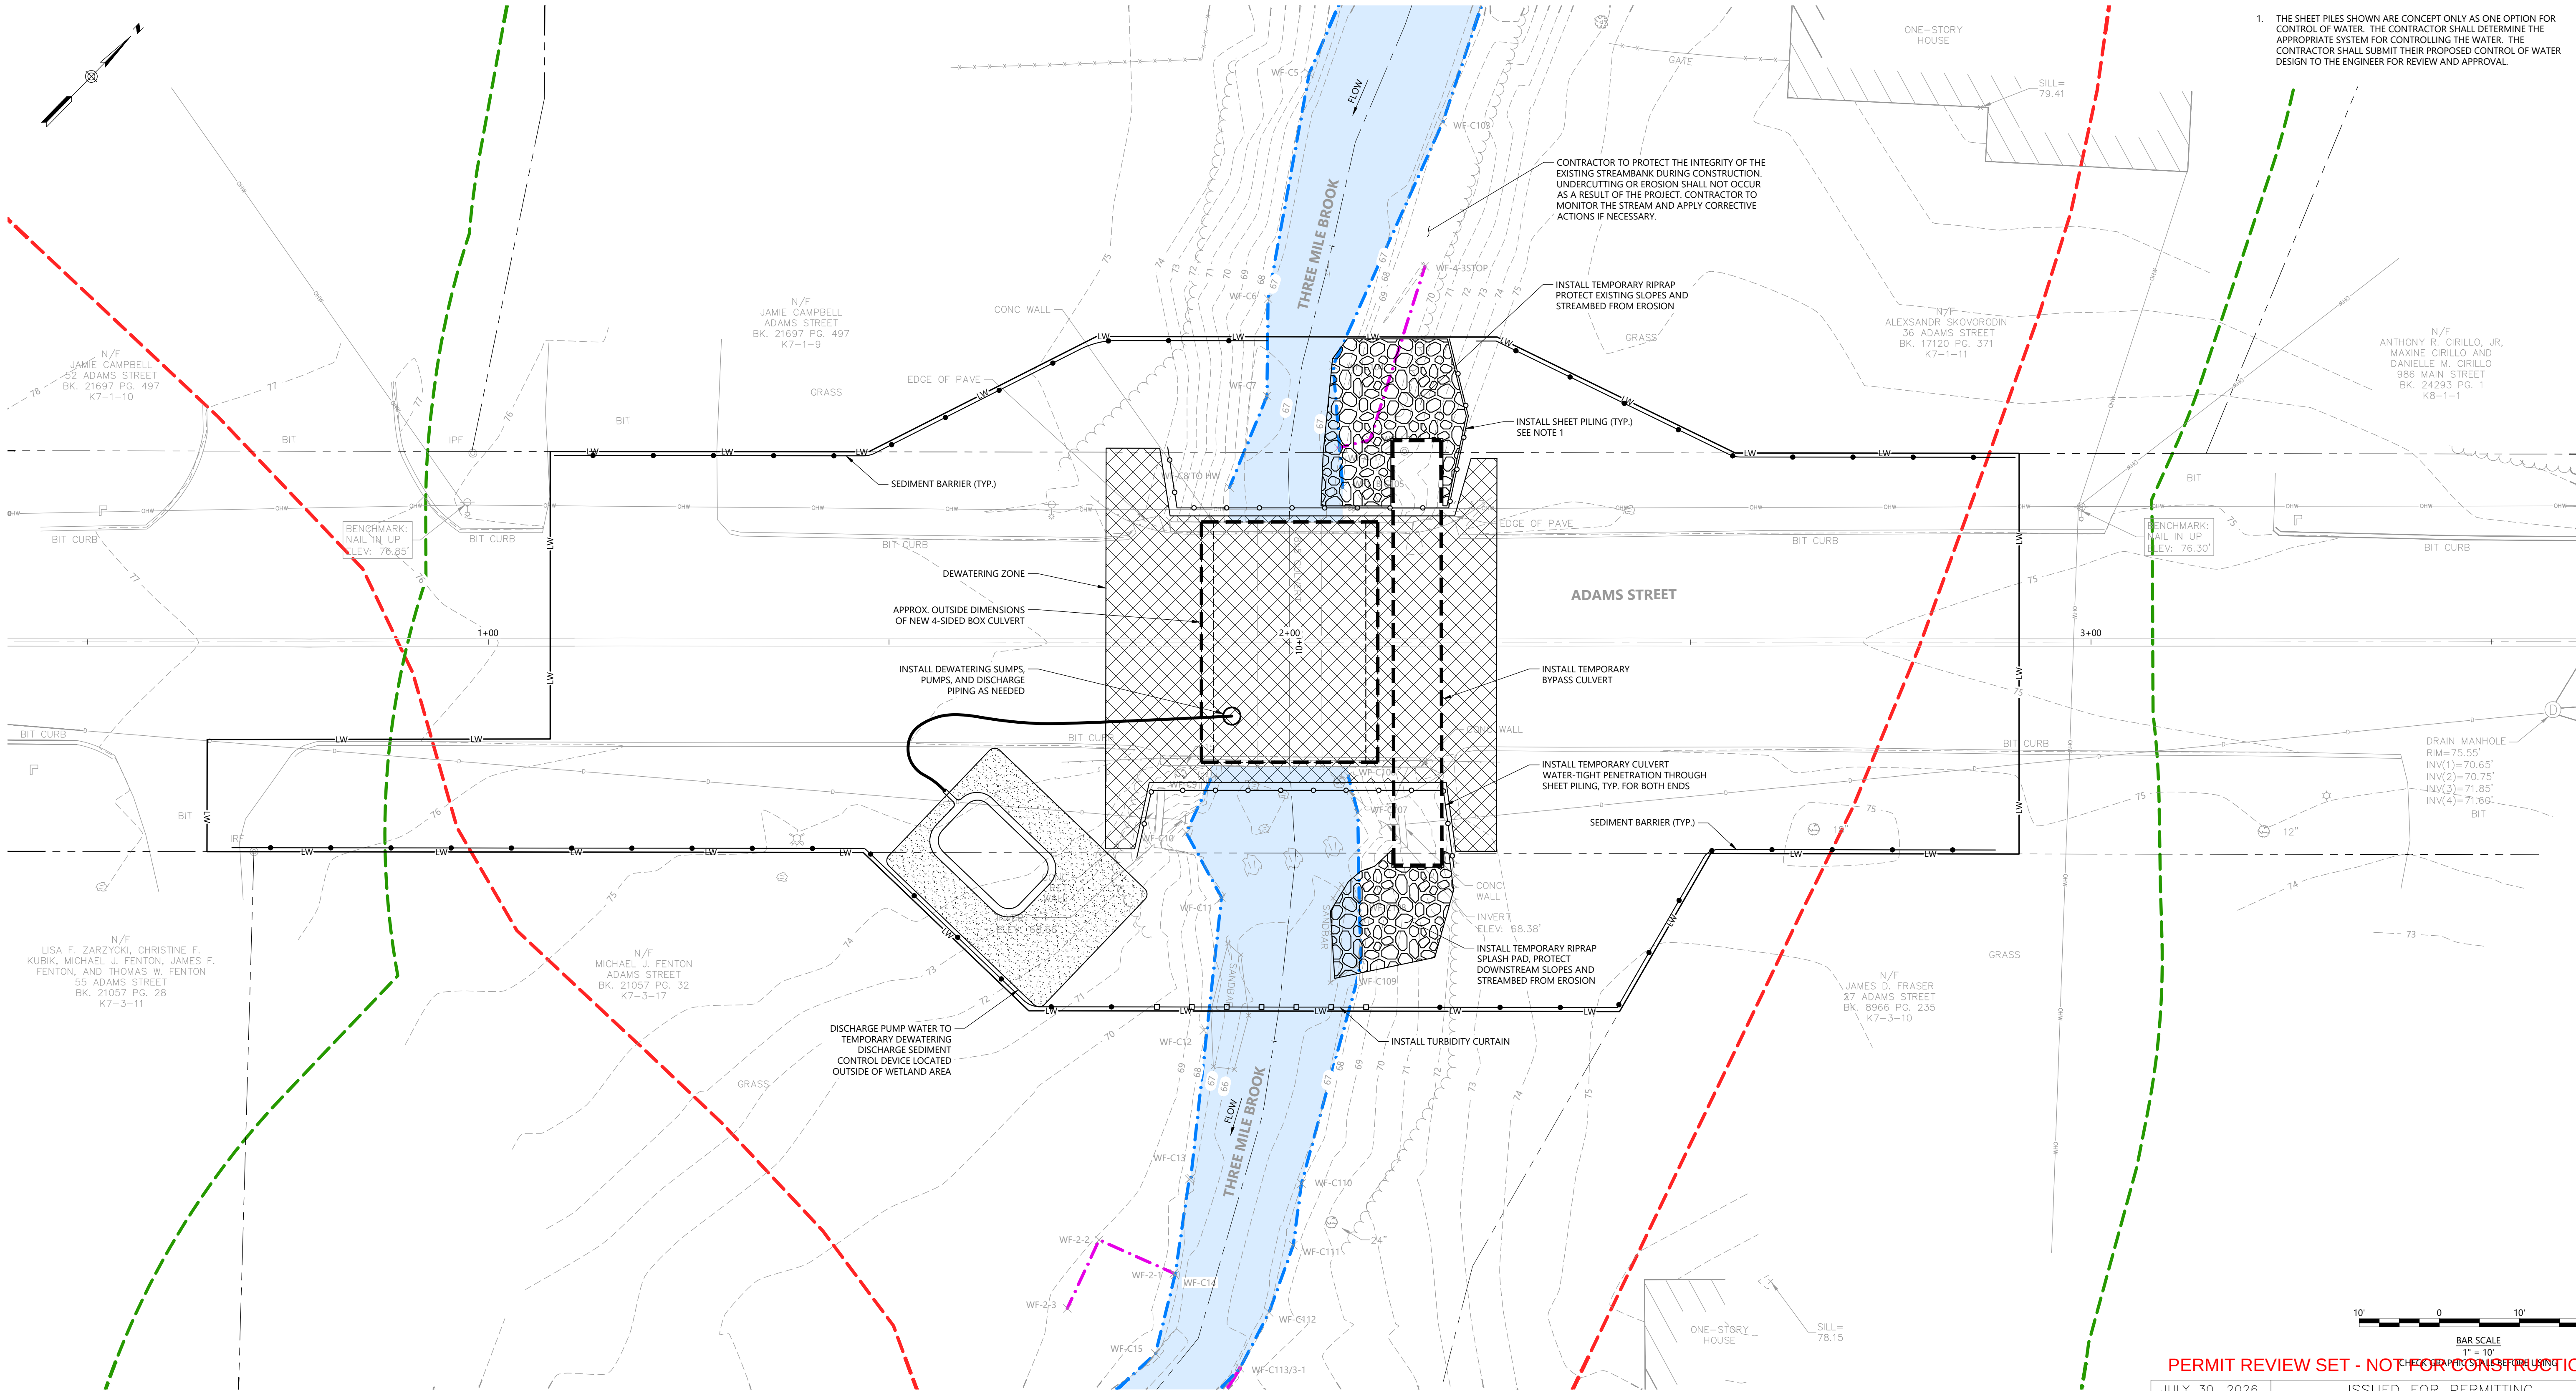
1. THE SHEET PILES SHOWN ARE CONCEPT ONLY AS ONE OPTION FOR CONTROL OF WATER. THE CONTRACTOR SHALL DETERMINE THE APPROPRIATE SYSTEM FOR CONTROLLING THE WATER. THE CONTRACTOR SHALL SUBMIT THEIR PROPOSED CONTROL OF WATER DESIGN TO THE ENGINEER FOR REVIEW AND APPROVAL.

TEMPORARY STREAM BYPASS PLAN
