## **Conservation Commission AGENDA**

TOWN OF AGAWAM  
ADAMS STREET

ADAMS ST CULVERT REPLACEMENT  
TOWN OF AGAWAM  
ADAMS STREET  
OVER THREE MILE BROOK

**Re: Notice of Intent Application**  
**Adams Street Over Three Mile Brook Culvert Replacement**  
**Agawam, Massachusetts**

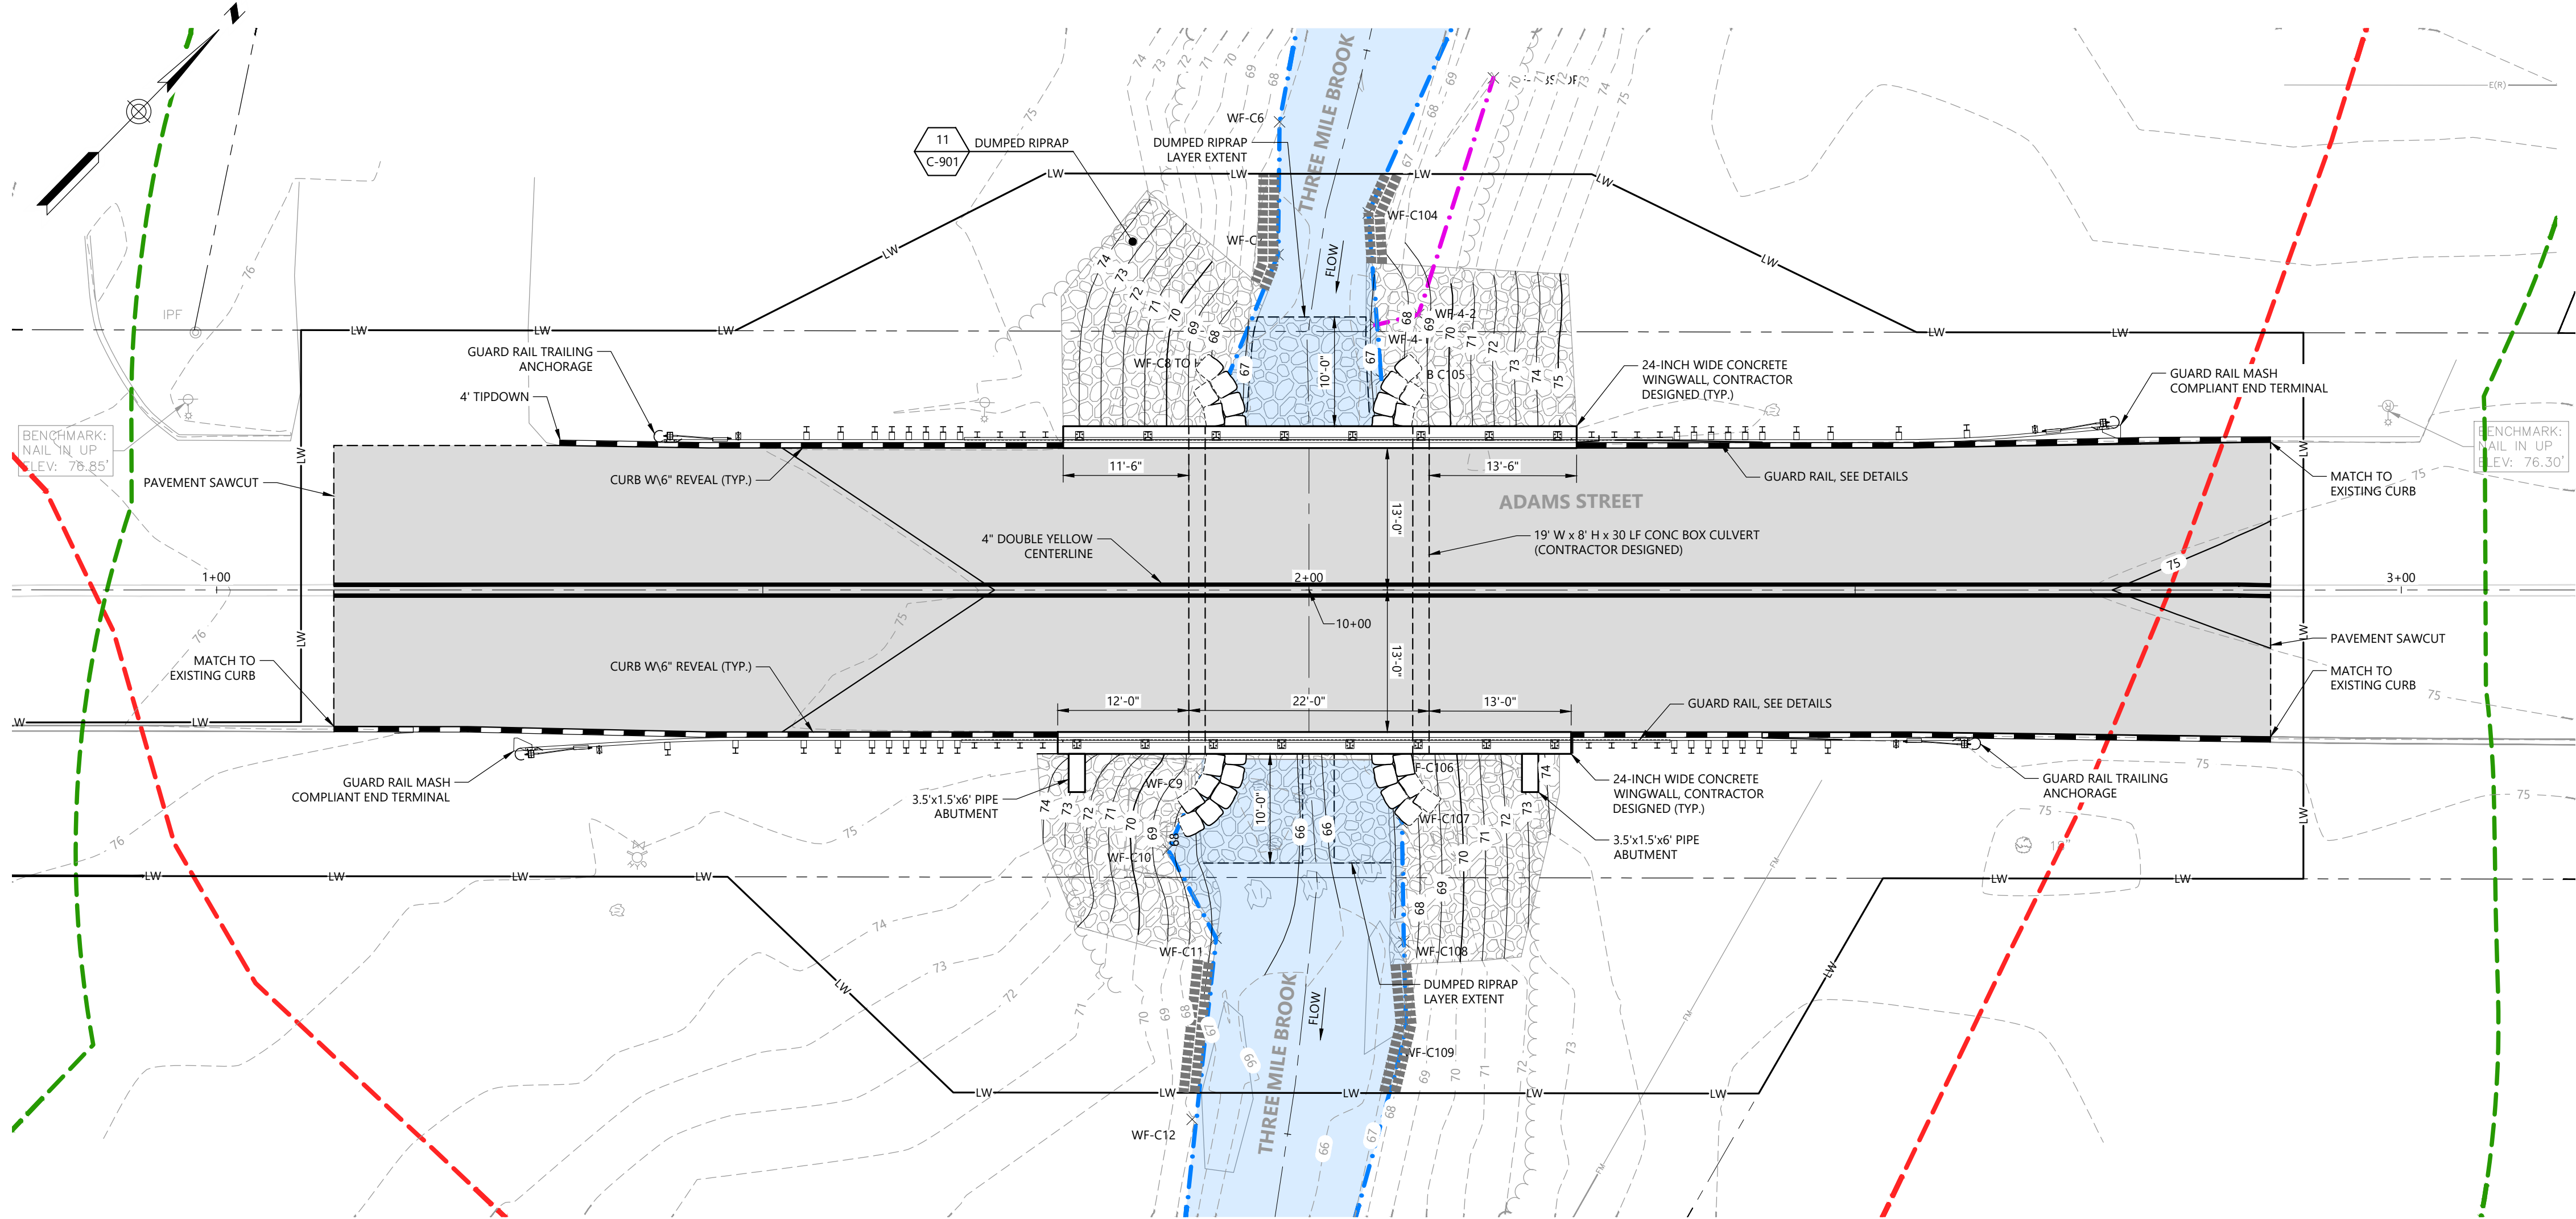
ADAMS STREET PROPOSED ROADWAY PLAN  
SCALE: 1" = 10'

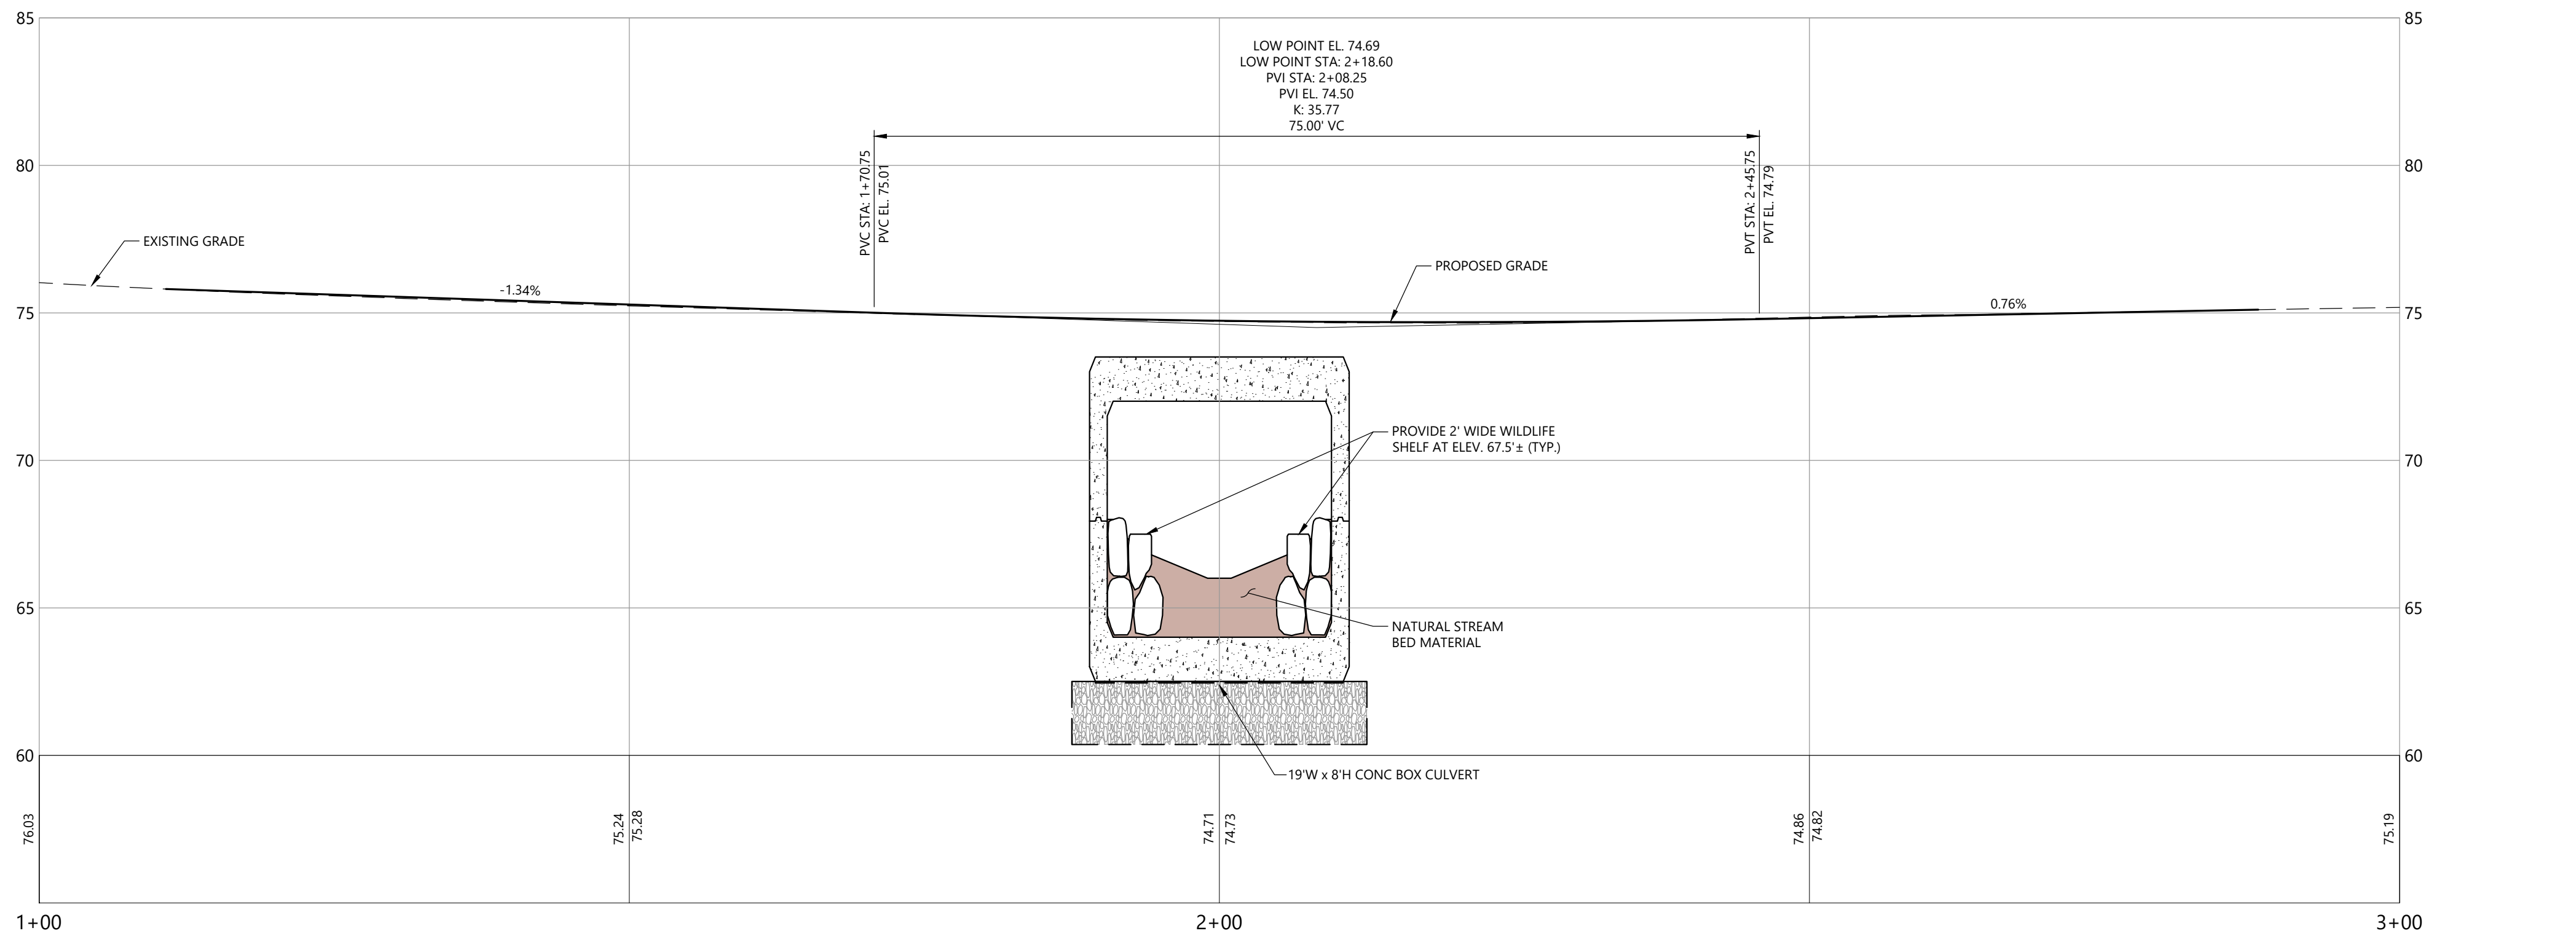
ADAMS STREET PROFILE STA. 1+00 TO STA. 3+00  
HORIZONTAL SCALE: 1" = 10'  
VERTICAL SCALE: 1" = 4'

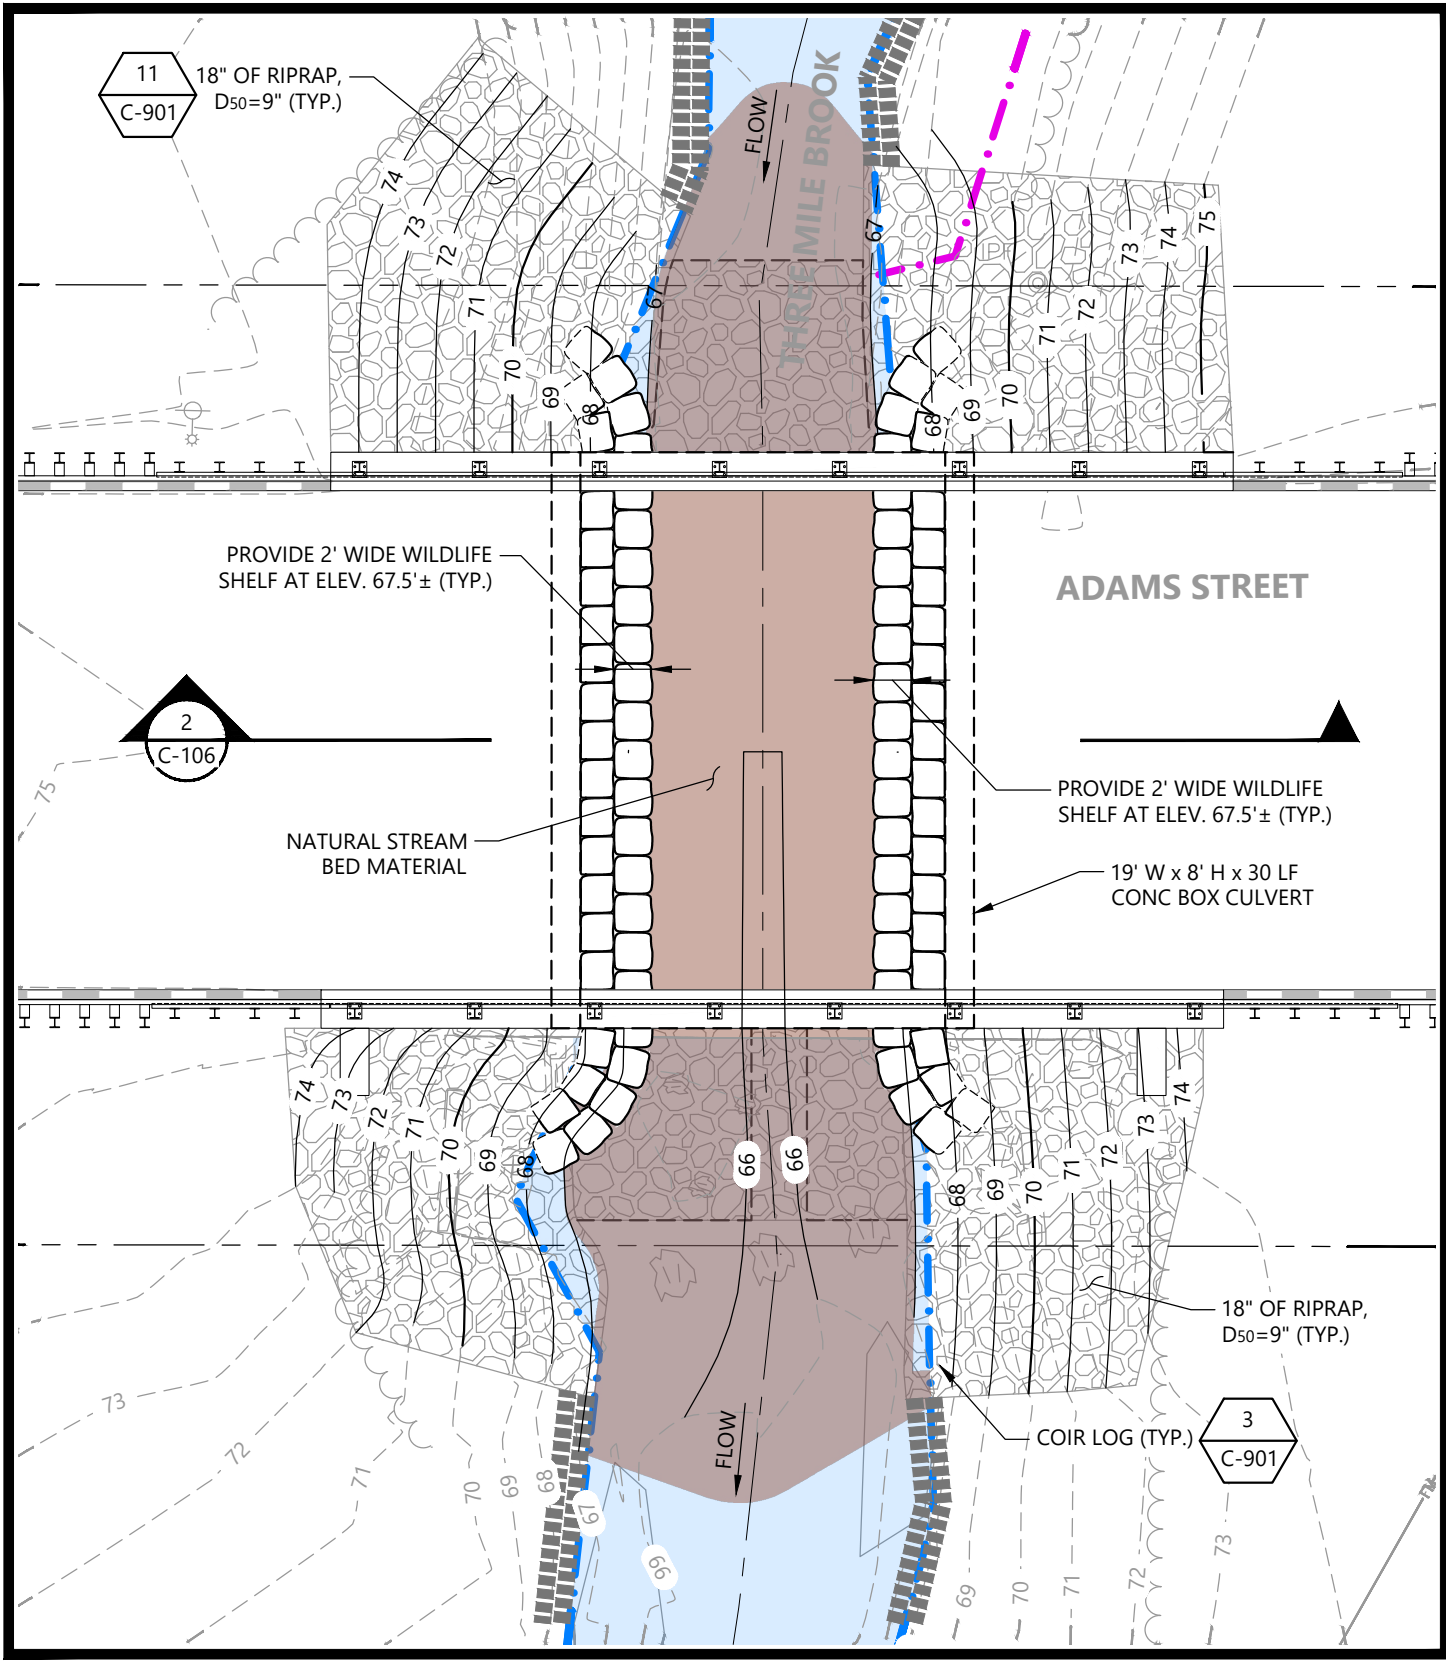
THREE MILE BROOK  
PROPOSED STREAM BED GRADING PLAN  
SCALE: 1" = 10'

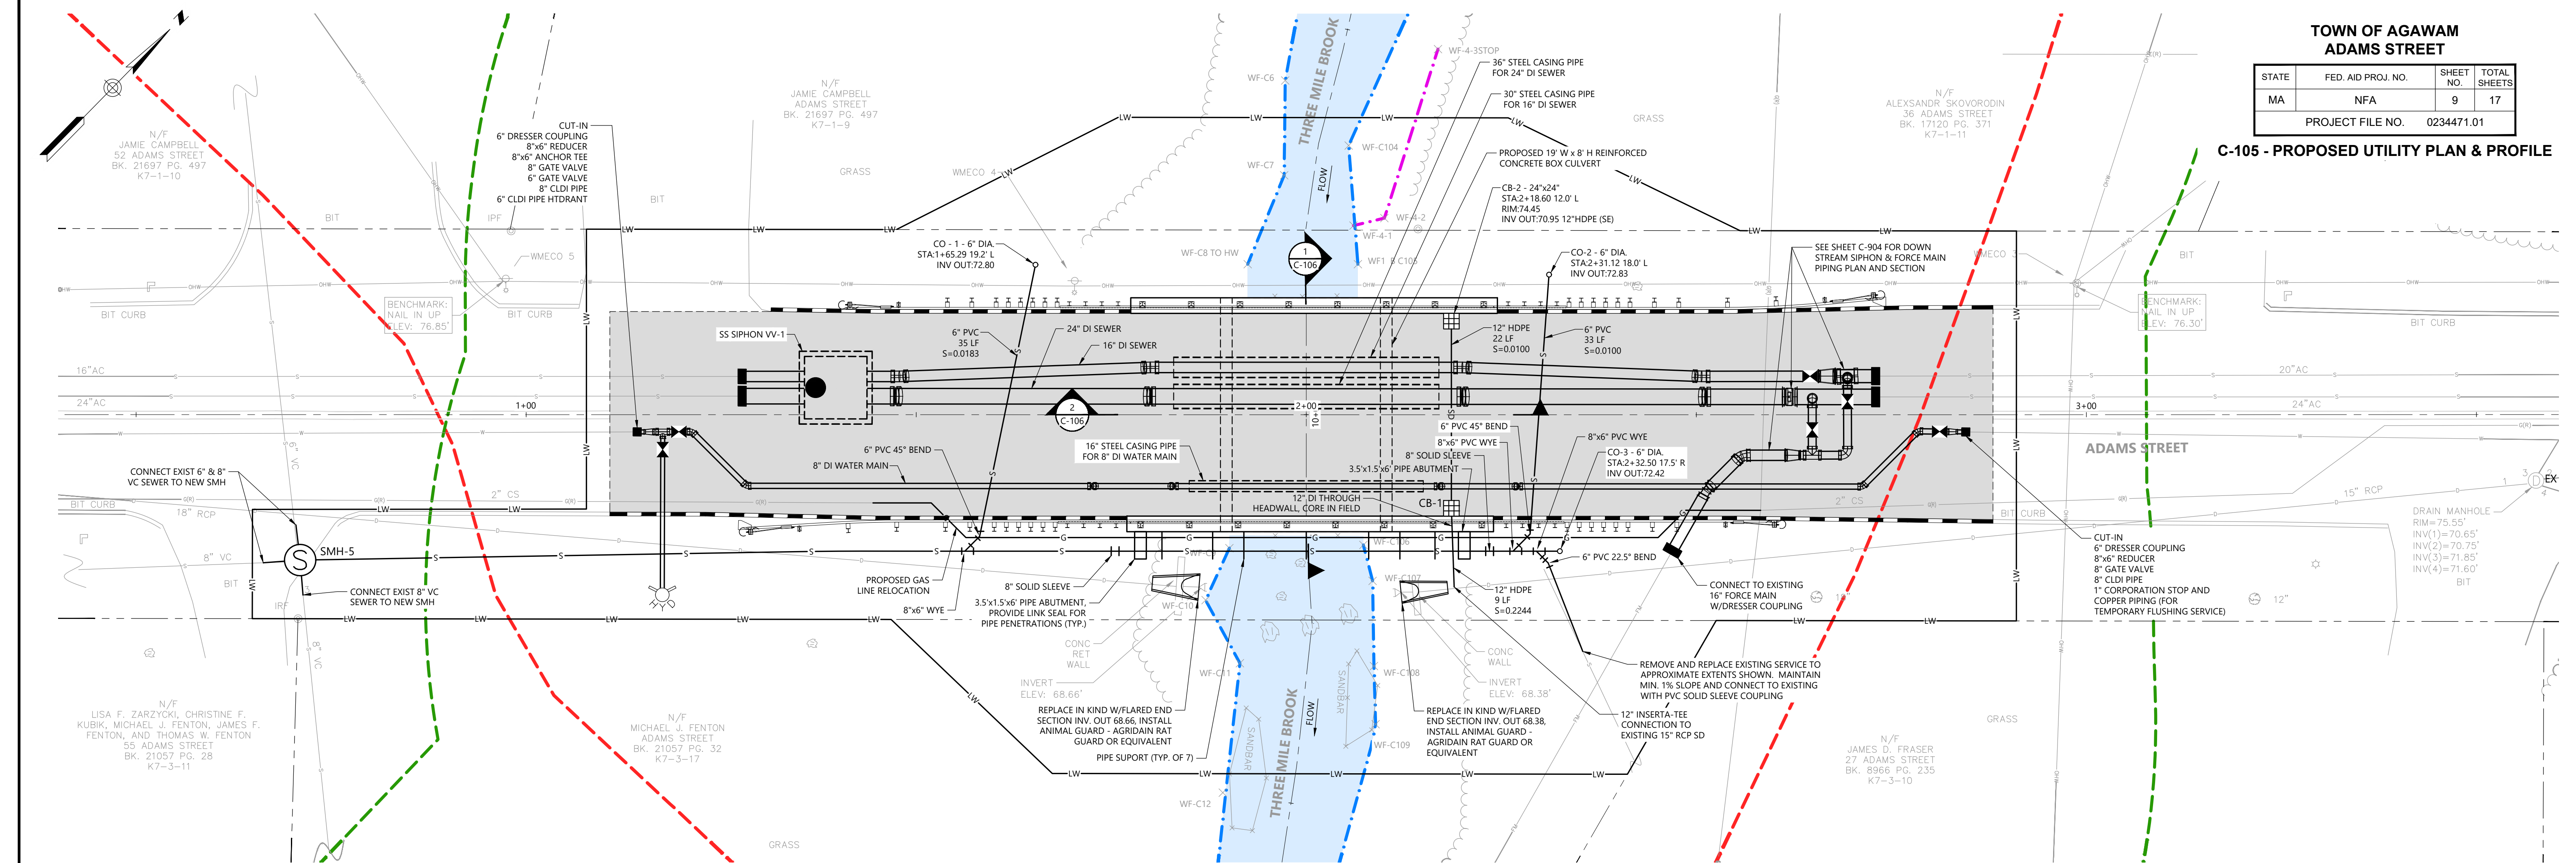
ADAMS STREET PROPOSED UTILITY PLAN

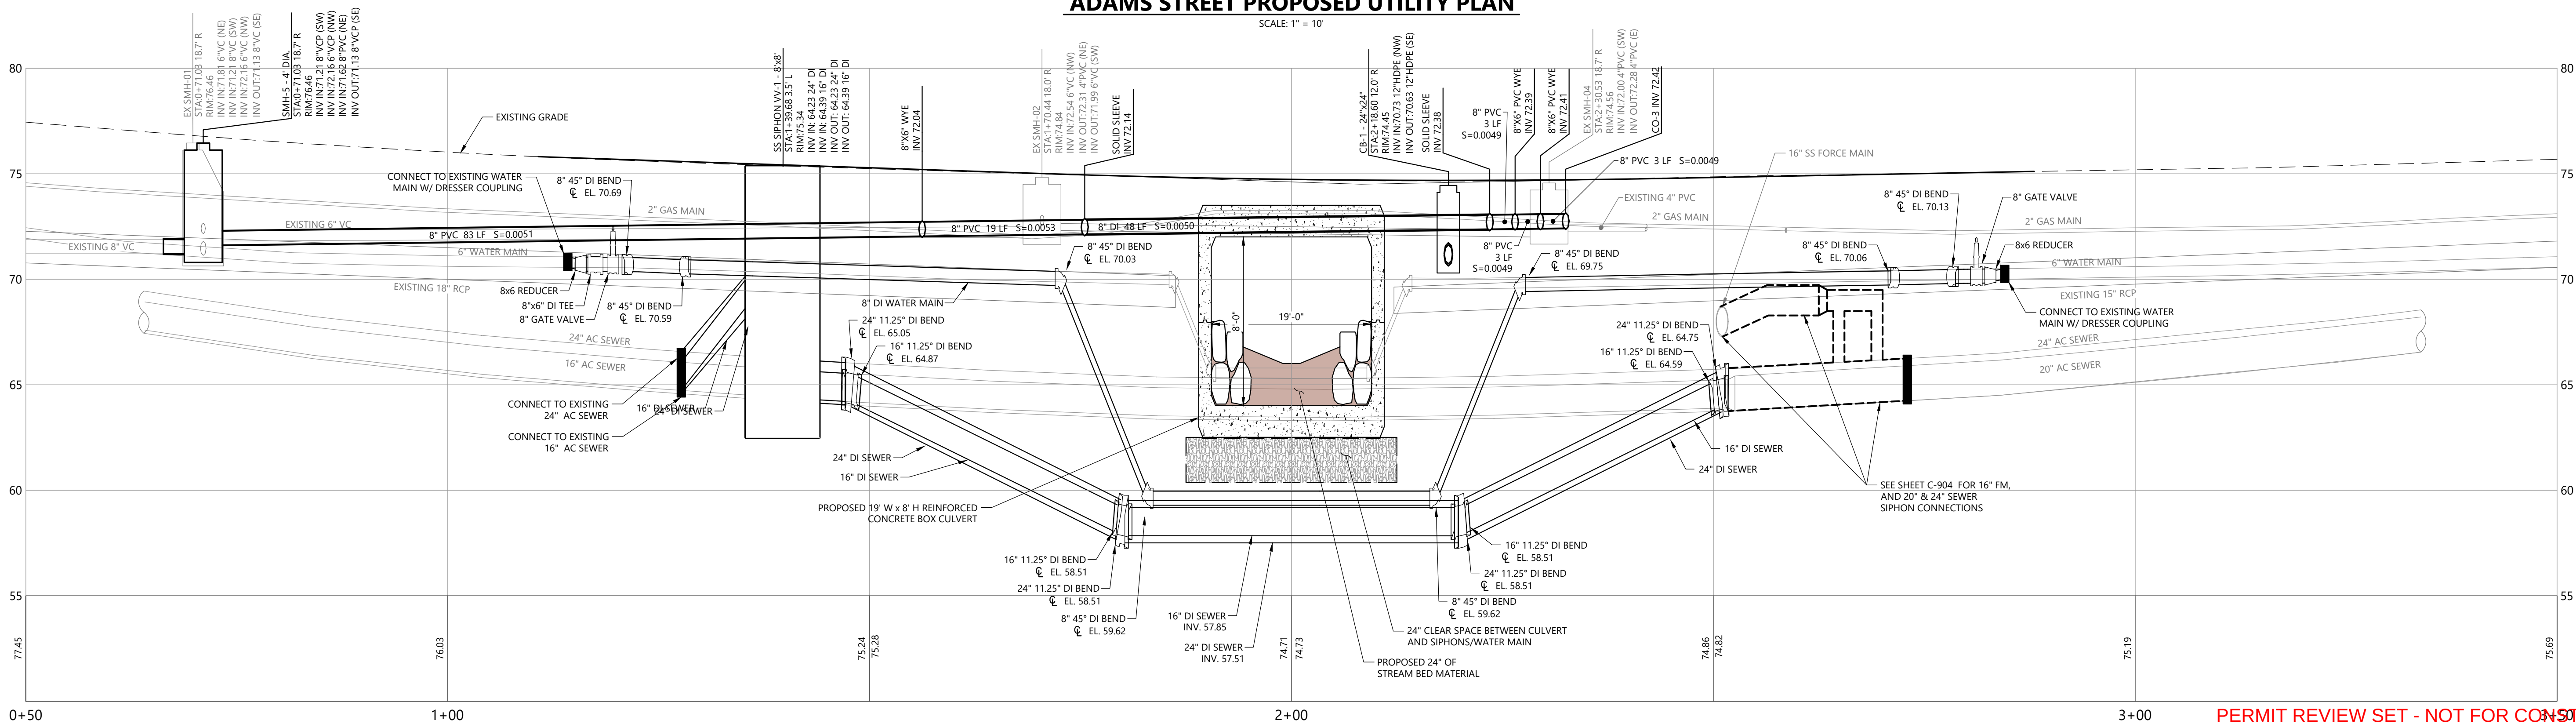
ADAMS STREET PROFILE STA. 0+50 TO STA. 3+50

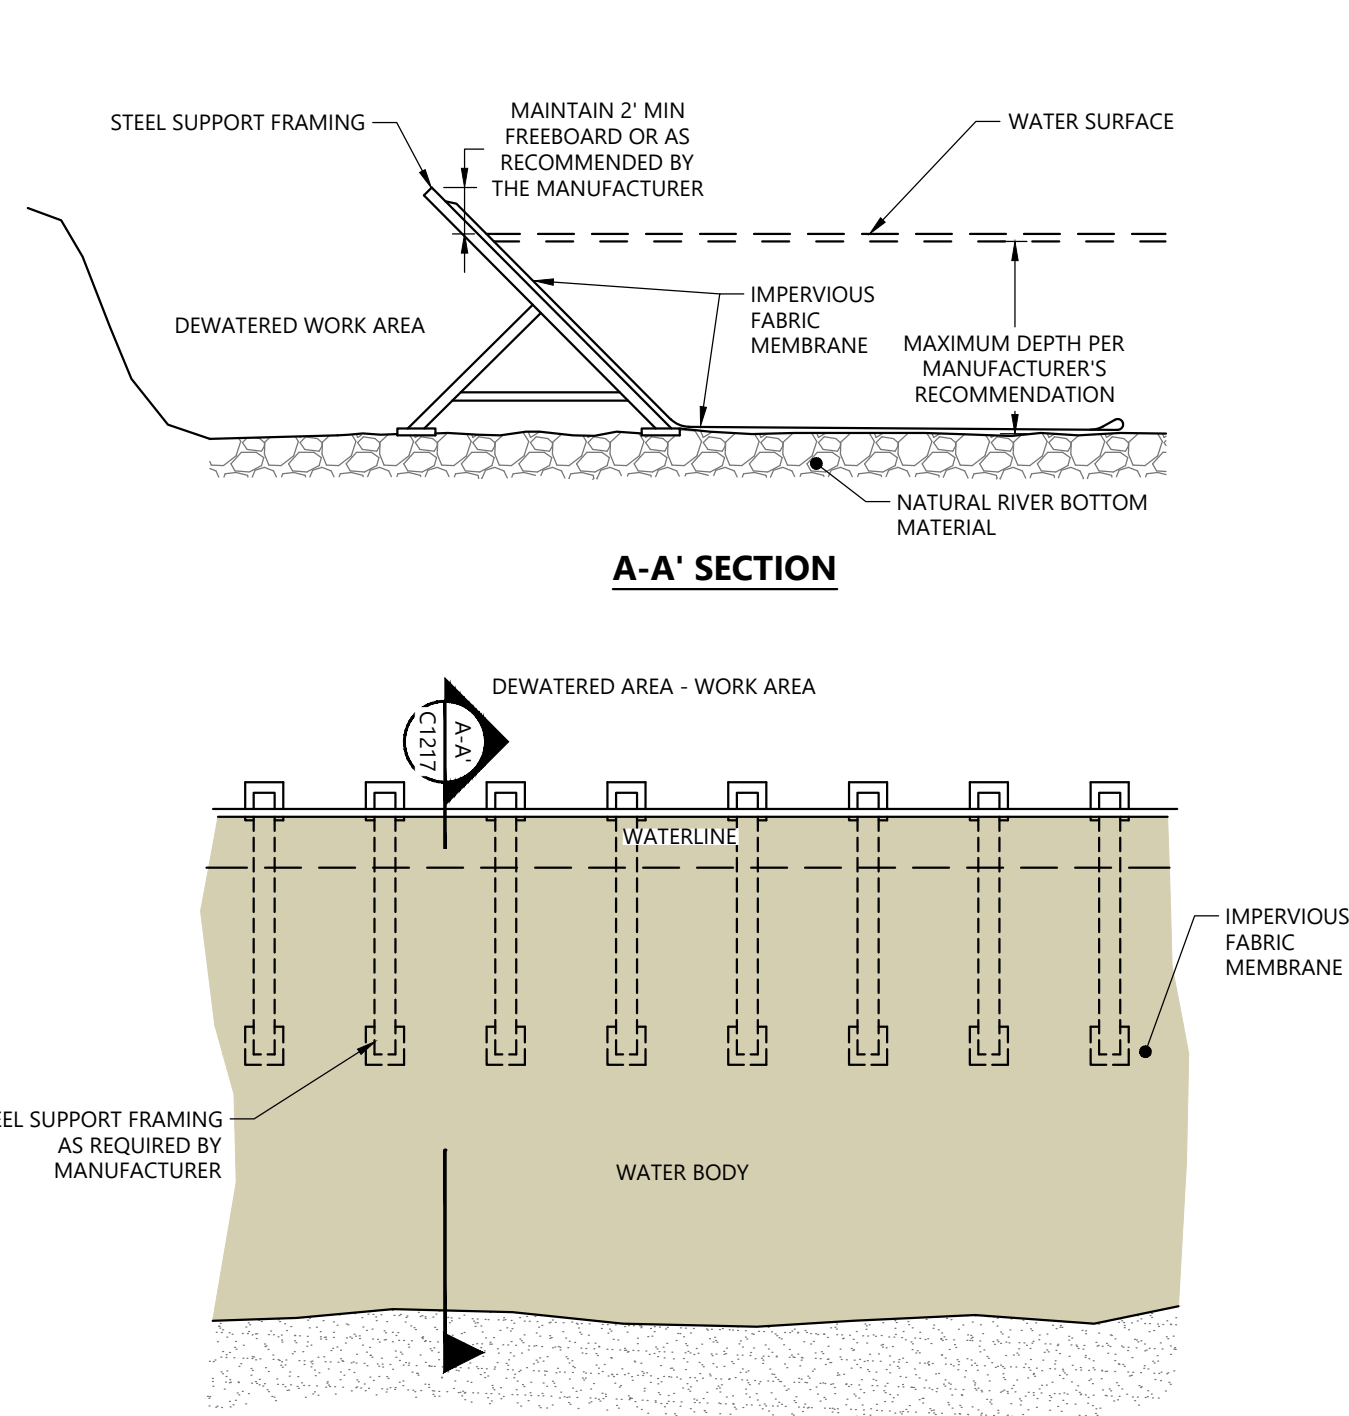
**2 COFFER DAM**  
NOT TO SCALE

- NOTES:
- COFFERDAM DETAIL SHOWN FOR REFERENCE PURPOSES. CONTRACTOR SHALL PROVIDE DESIGN OF TEMPORARY COFFERDAMS, STAMPED BY A LICENSED PROFESSIONAL ENGINEER IN THE STATE OF XXXXX.
  - COFFERDAM TO BE INSTALLED AROUND WORK AREA IN ACCORDANCE WITH CONTRACTOR'S WORK PLAN.

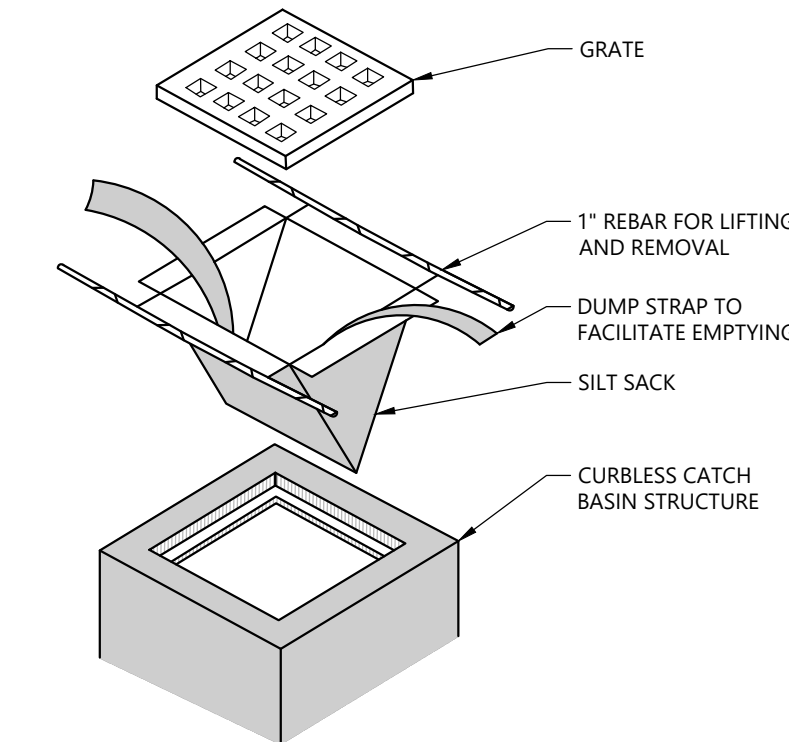
**5 SILTSACK - CURBLESS INLET**  
NOT TO SCALE

- NOTES:
- INSTALL SILTSACK PER MANUFACTURER'S INSTRUCTIONS AND RECOMMENDATIONS.
  - EMPTY OR REMOVE SEDIMENT FROM SILTSACK WHEN RESTRAINT CORD IS NO LONGER VISIBLE. CLEAN, RINSE, AND REPLACE AS NEEDED.
  - SILT SACKS TO BE INSTALLED WHEN THE POTENTIAL FOR SEDIMENT TO ENTER EXISTING & PROPOSED BASINS EXISTS.

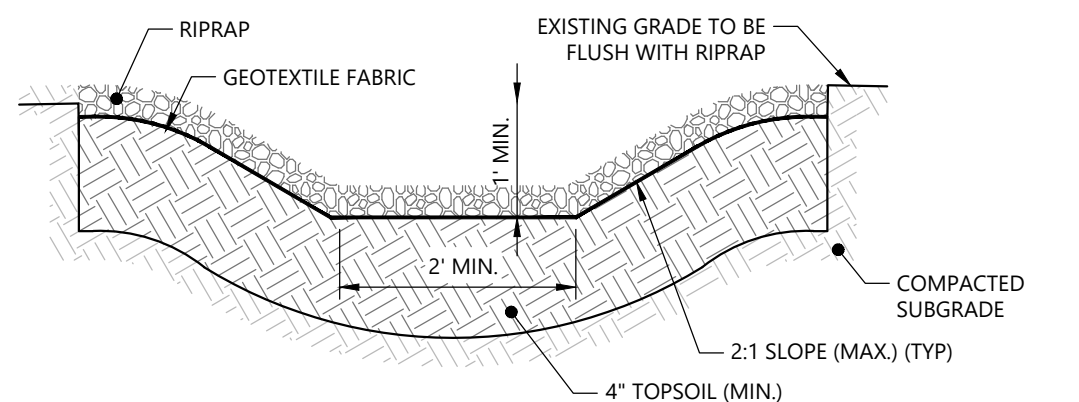
**9 DRAINAGE CHANNEL**  
NOT TO SCALE

- NOTES:
- FOR GRASS CHANNEL SLOPES EXCEEDING 8%, JUTE MESH OR EROSION CONTROL BLANKET SHALL BE INSTALLED TO STABILIZE THE CHANNEL BASE.
  - DISTURBED AREA ADJACENT TO CHANNEL TO BE BROUGHT TO FINISHED GRADE IMMEDIATELY, TOPSOILED, SEEDDED AND MAINTAINED FOR EROSION CONTROL.

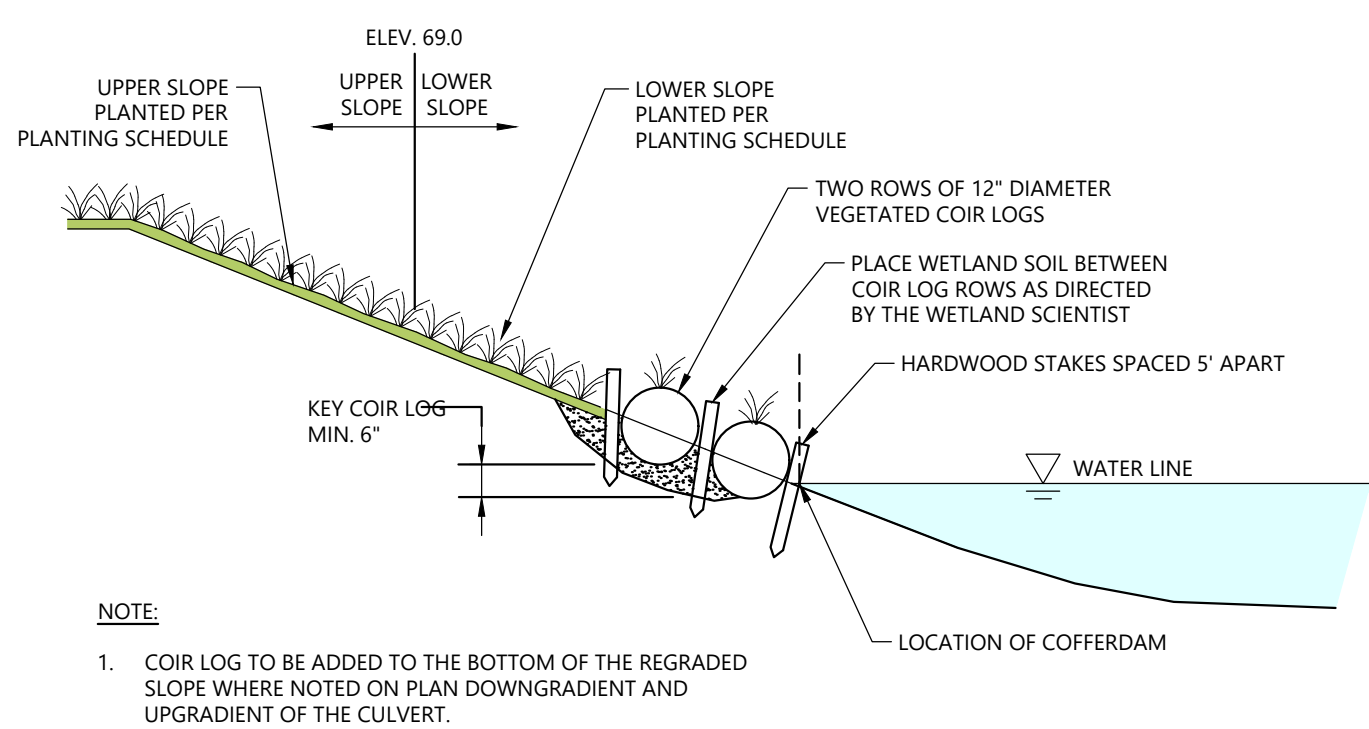
**3 COIR LOG**  
NOT TO SCALE

- NOTE:
- COIR LOG TO BE ADDED TO THE BOTTOM OF THE REGRADED SLOPE WHERE NOTED ON PLAN DOWNGRADIENT AND UPGRADEMENT OF THE CULVERT.

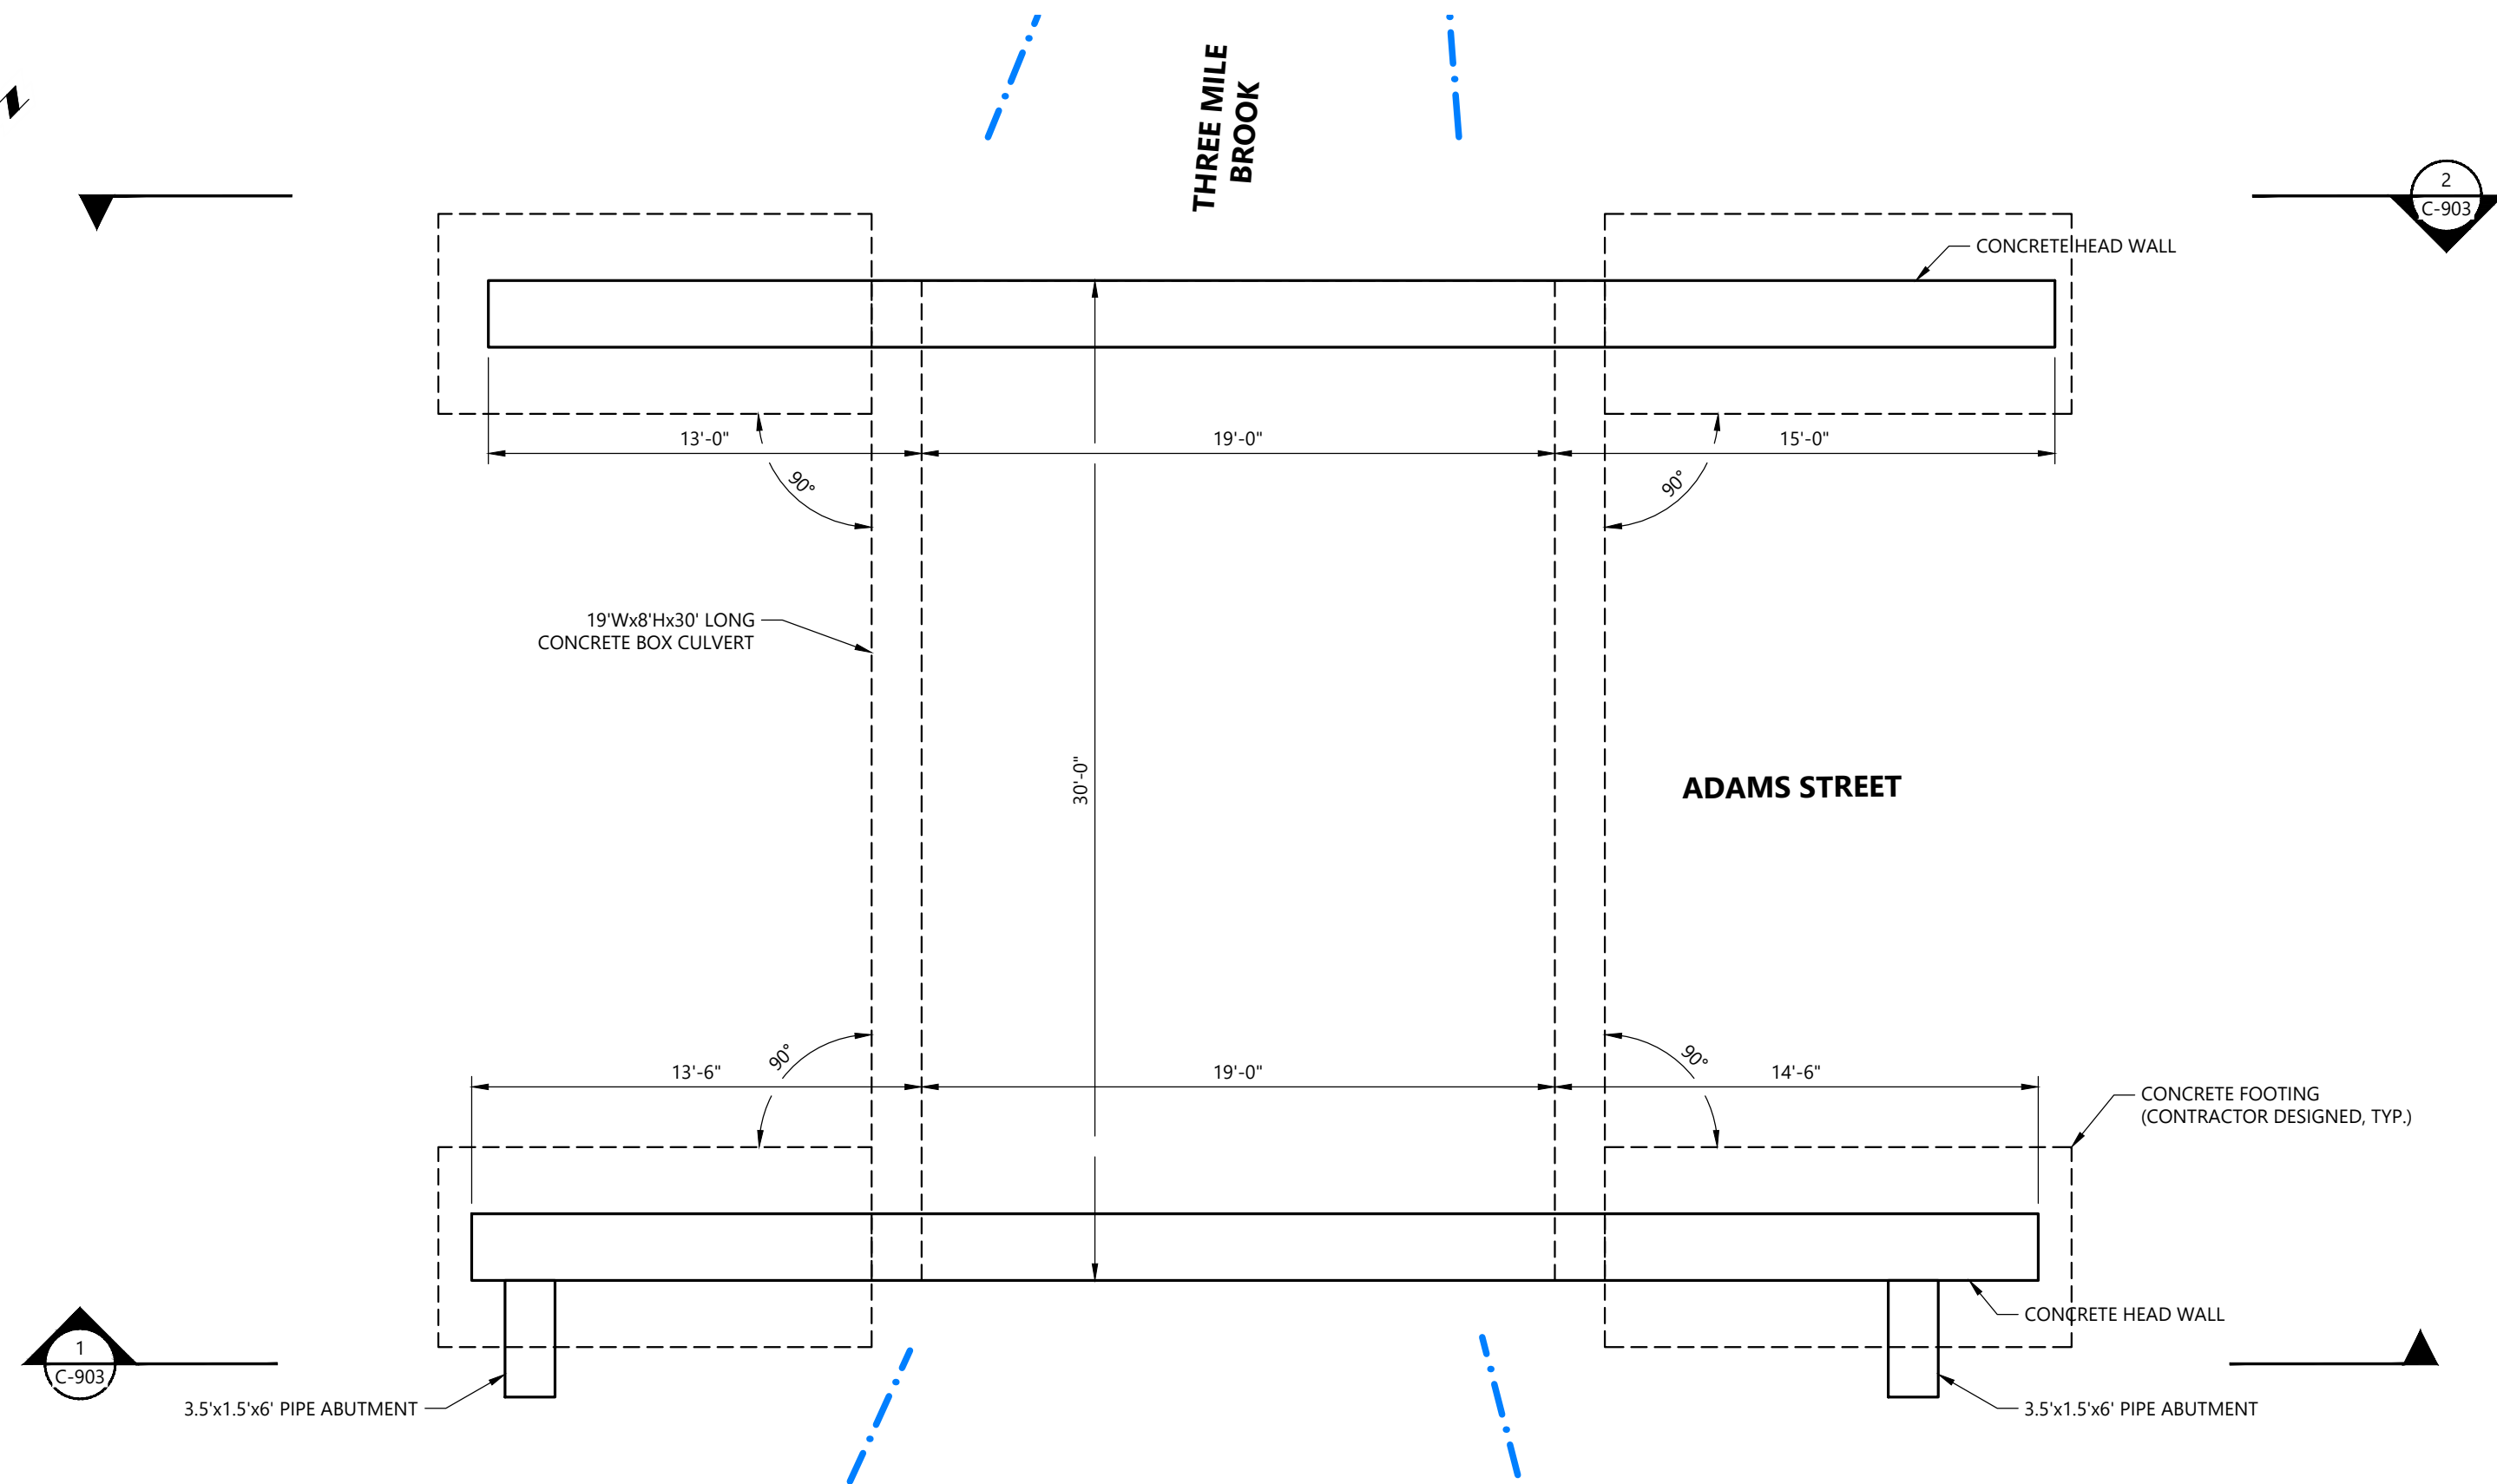
CULVERT SYSTEM PLAN VIEW

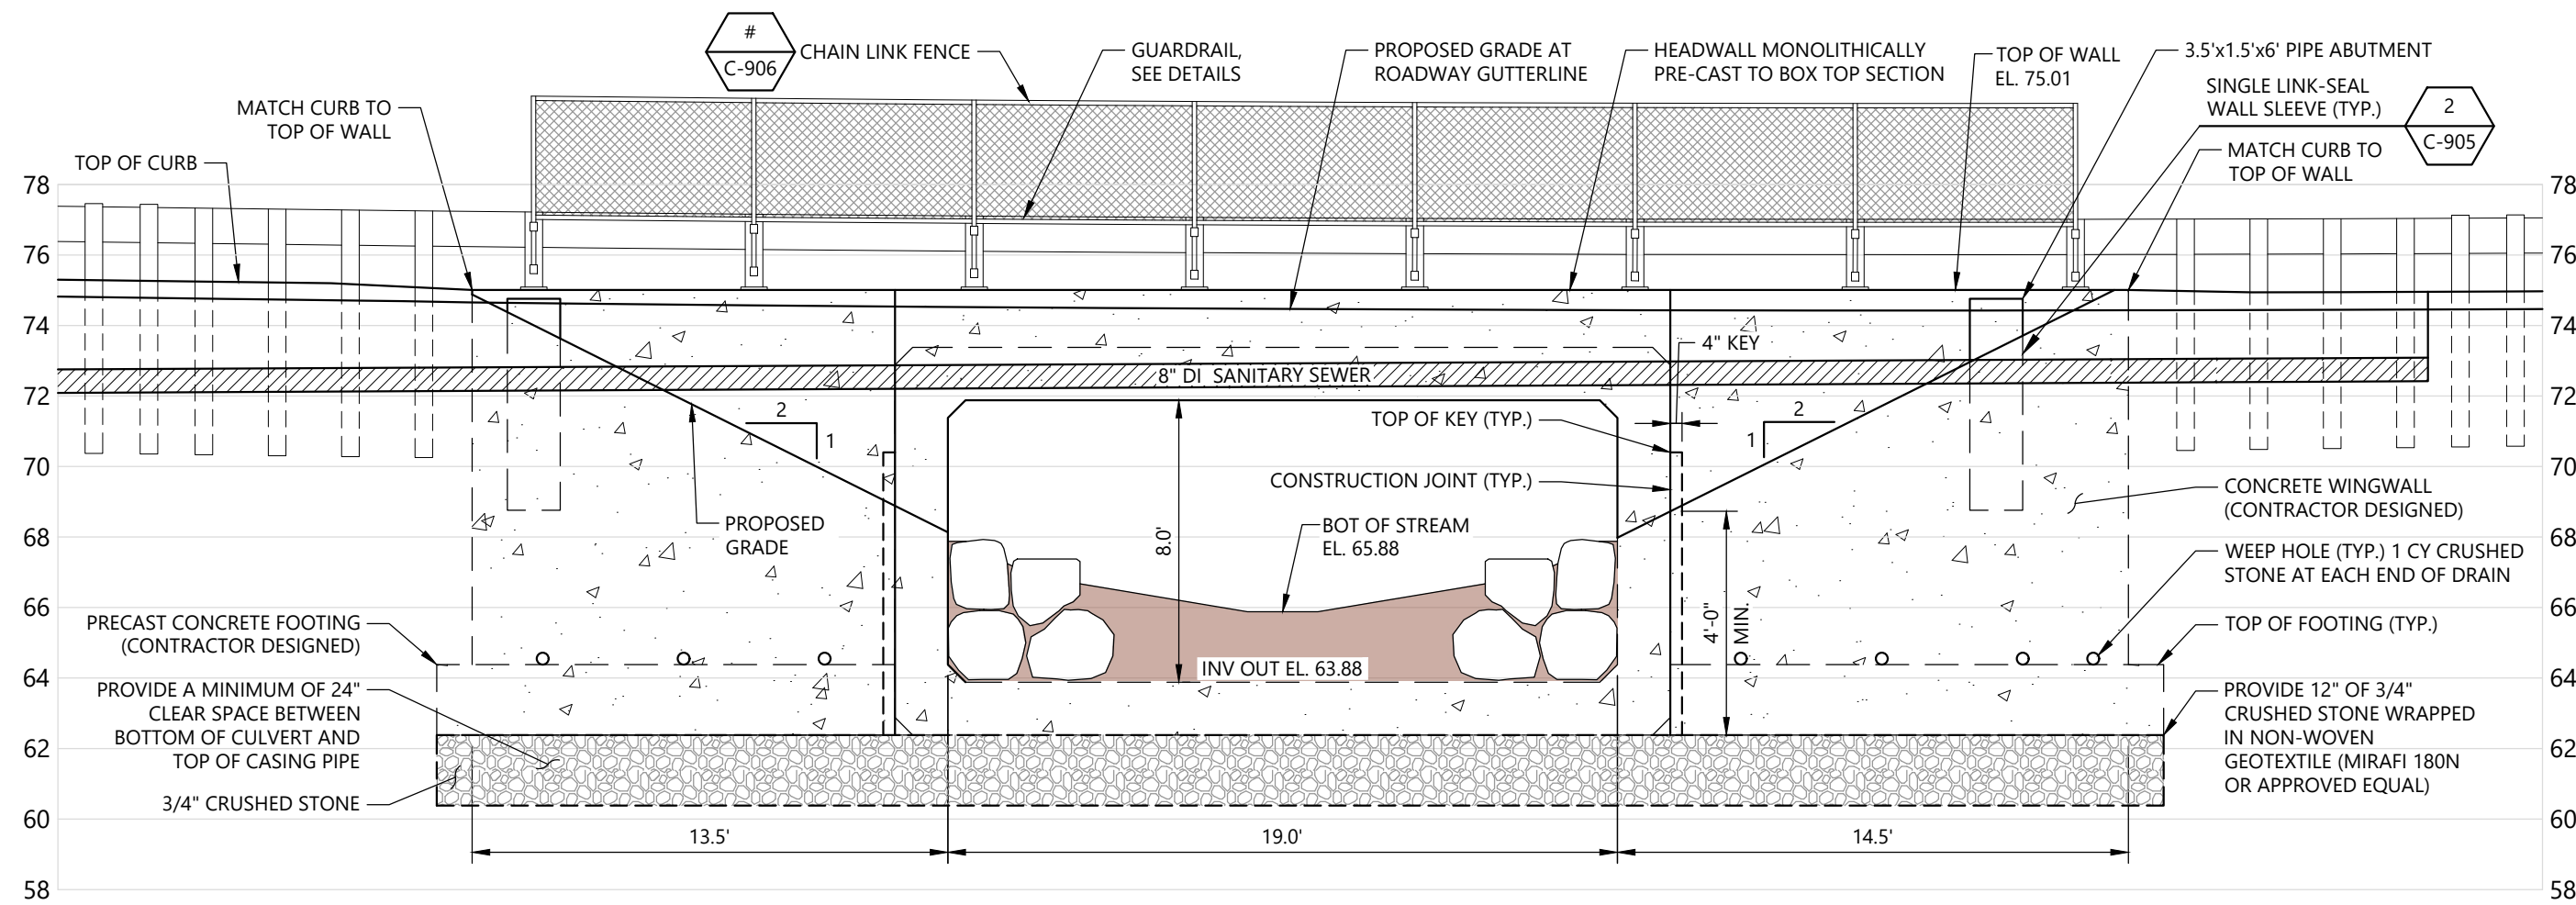
CULVERT OUTLET EXPANDED VIEW
