## **Conservation Commission AGENDA**

TOWN OF AGAWAM  
ADAMS STREET

ADAMS ST CULVERT REPLACEMENT  
TOWN OF AGAWAM  
ADAMS STREET  
OVER THREE MILE BROOK

**Re: Notice of Intent Application**  
**Adams Street Over Three Mile Brook Culvert Replacement**  
**Agawam, Massachusetts**

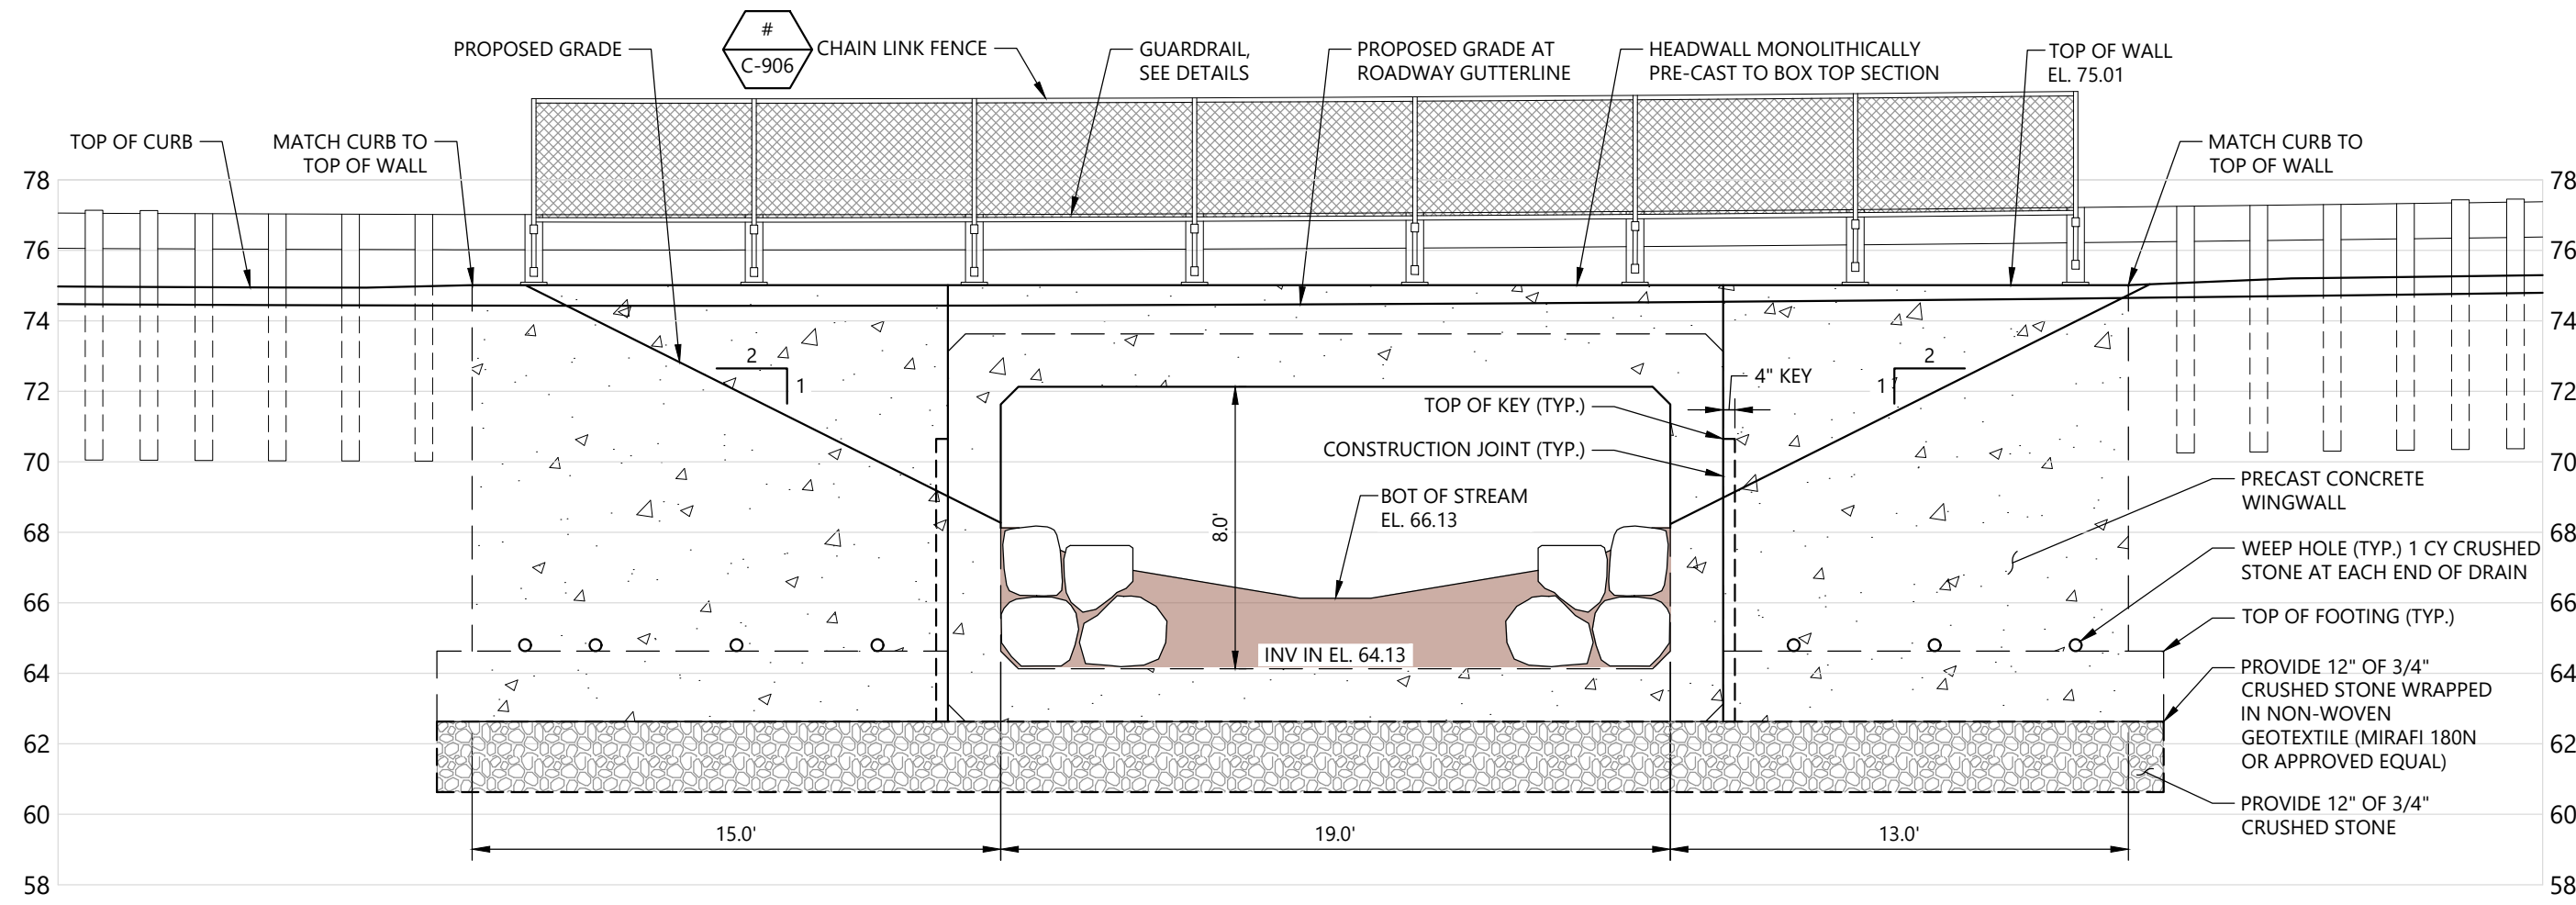
CULVERT INLET EXPANDED VIEW

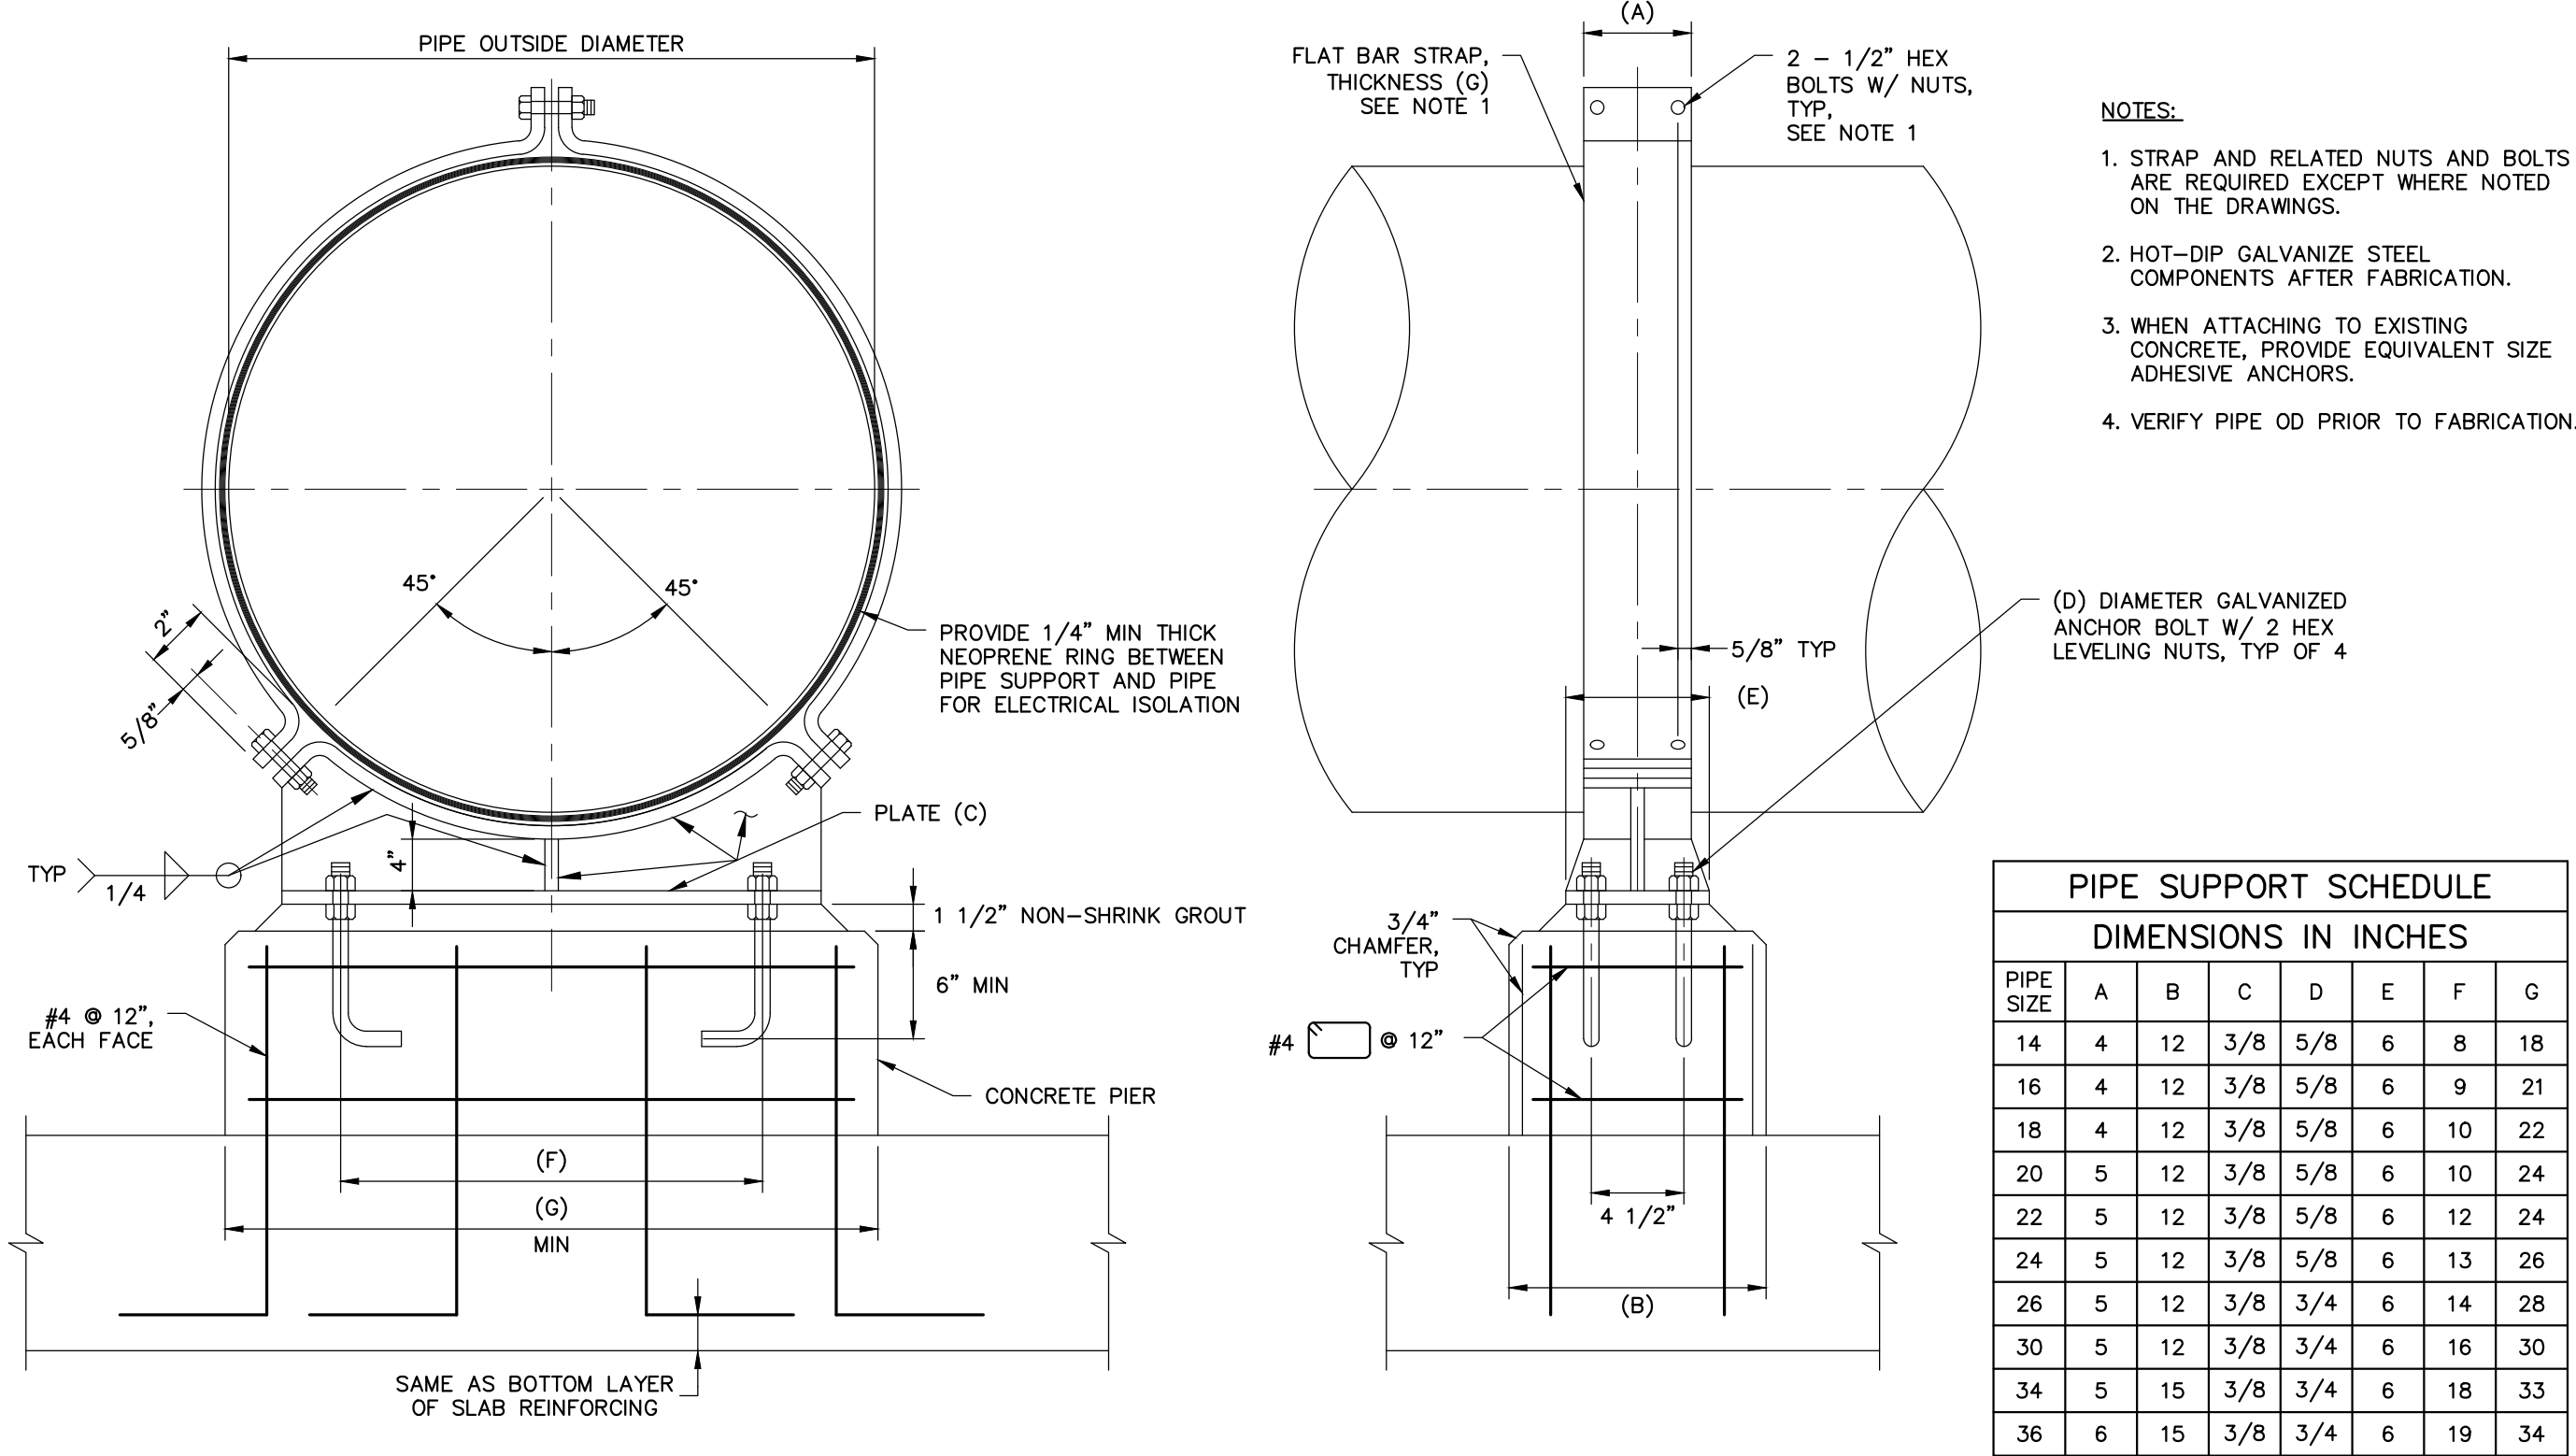
1 **CONCRETE PIER WITH FLAT BAR STRAP (VALVE VAULT)**  
NOT TO SCALE

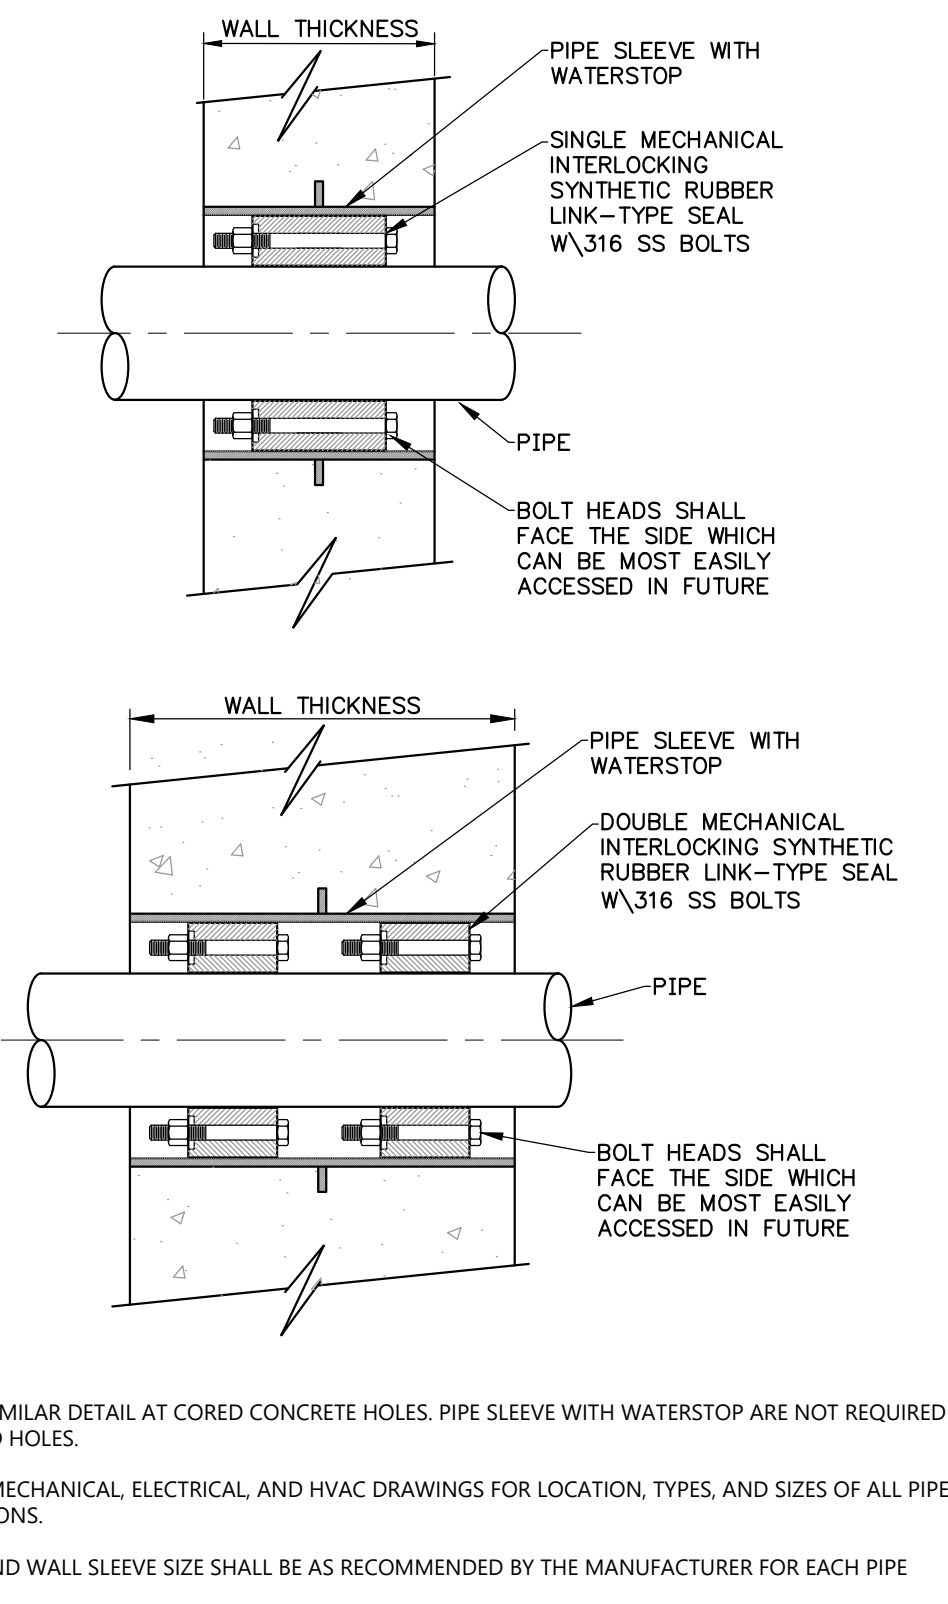
2 **SINGLE-DOUBLE LINK-SEAL WALL SLEEVE**  
NOT TO SCALE

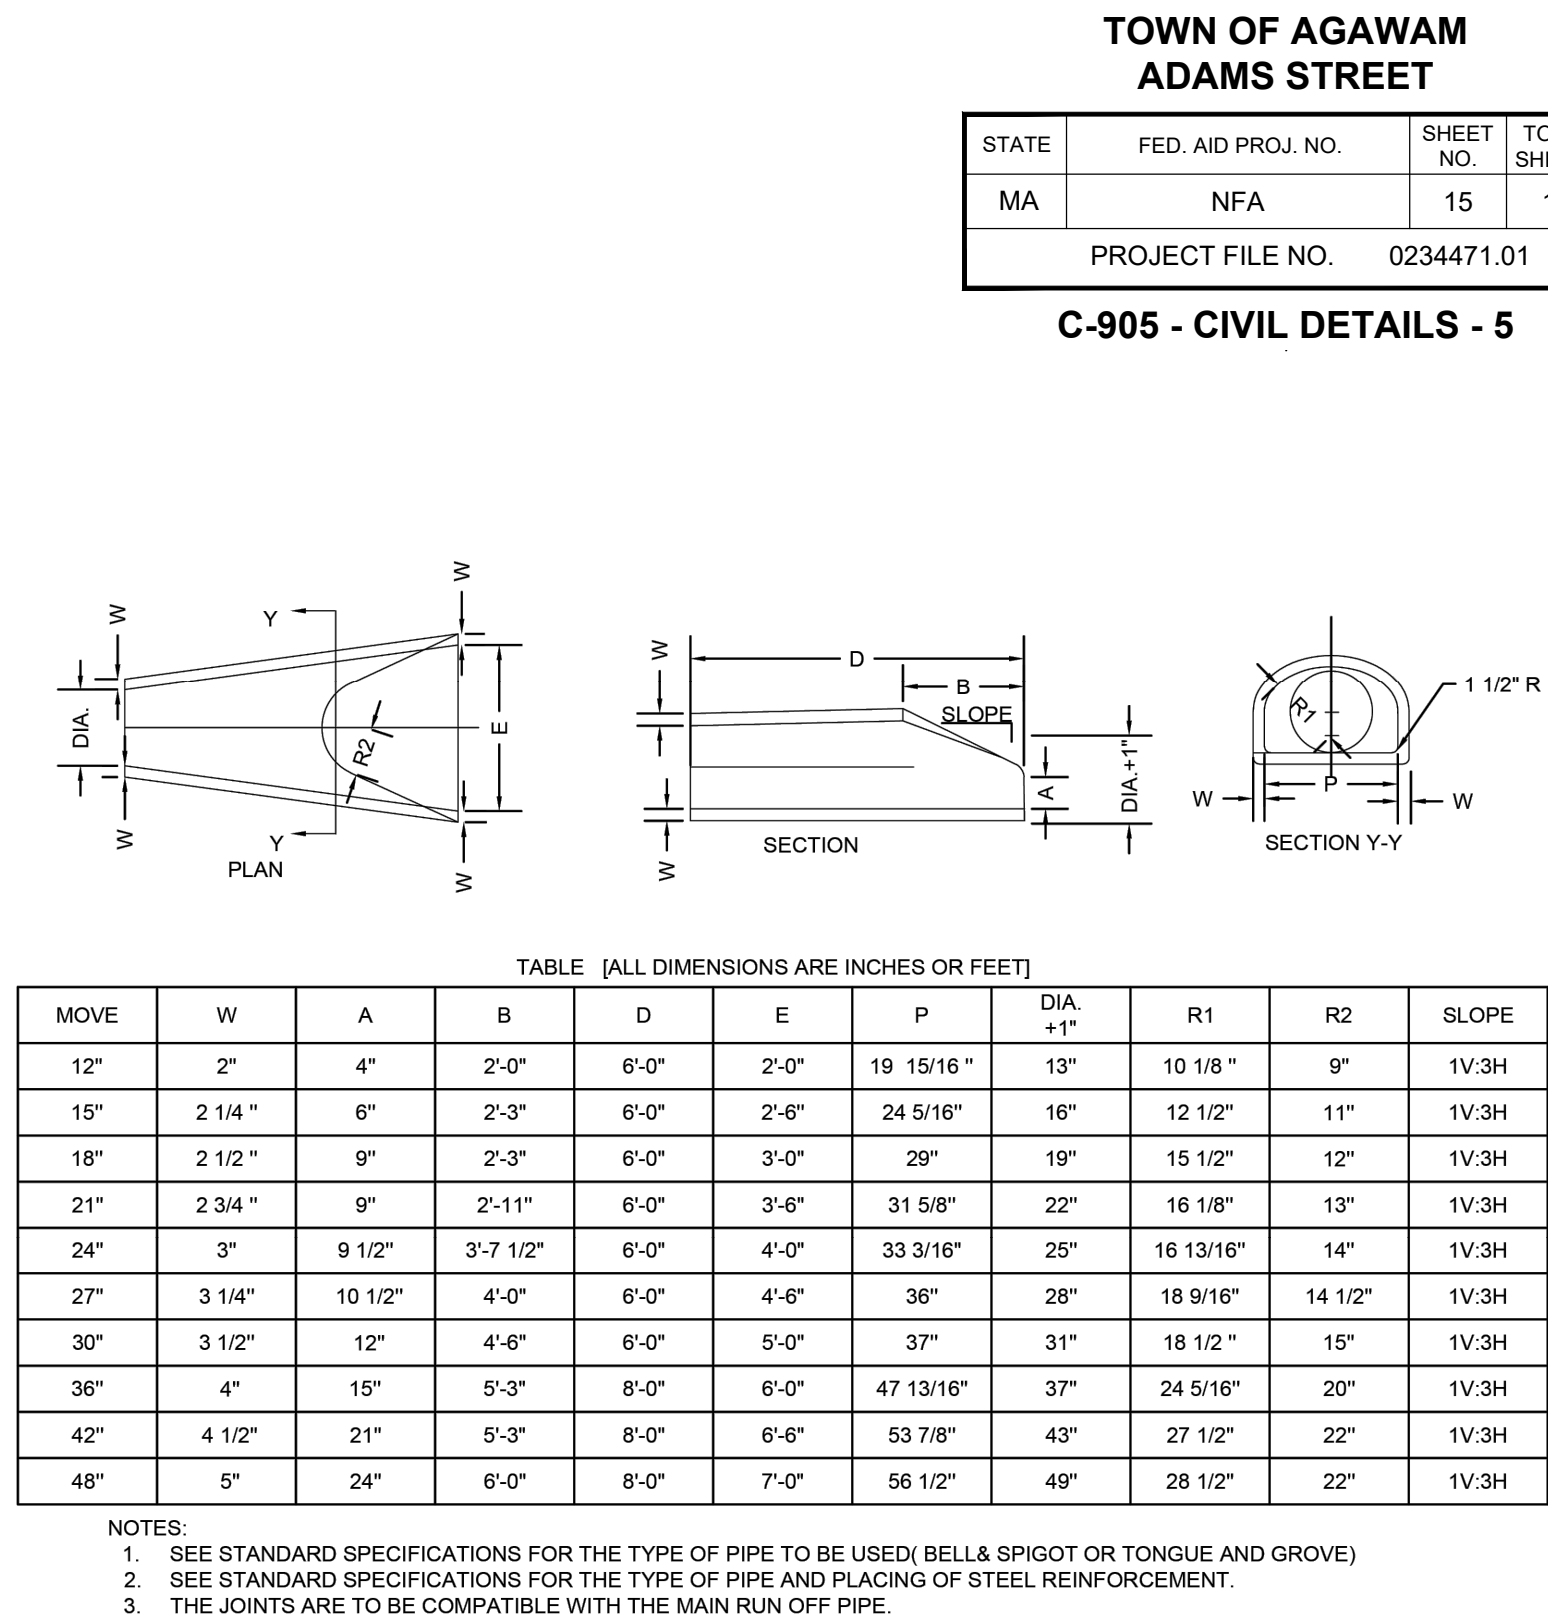
3 **REINFORCED CONCRETE PIPE FLARED ENDS**  
NOT TO SCALE

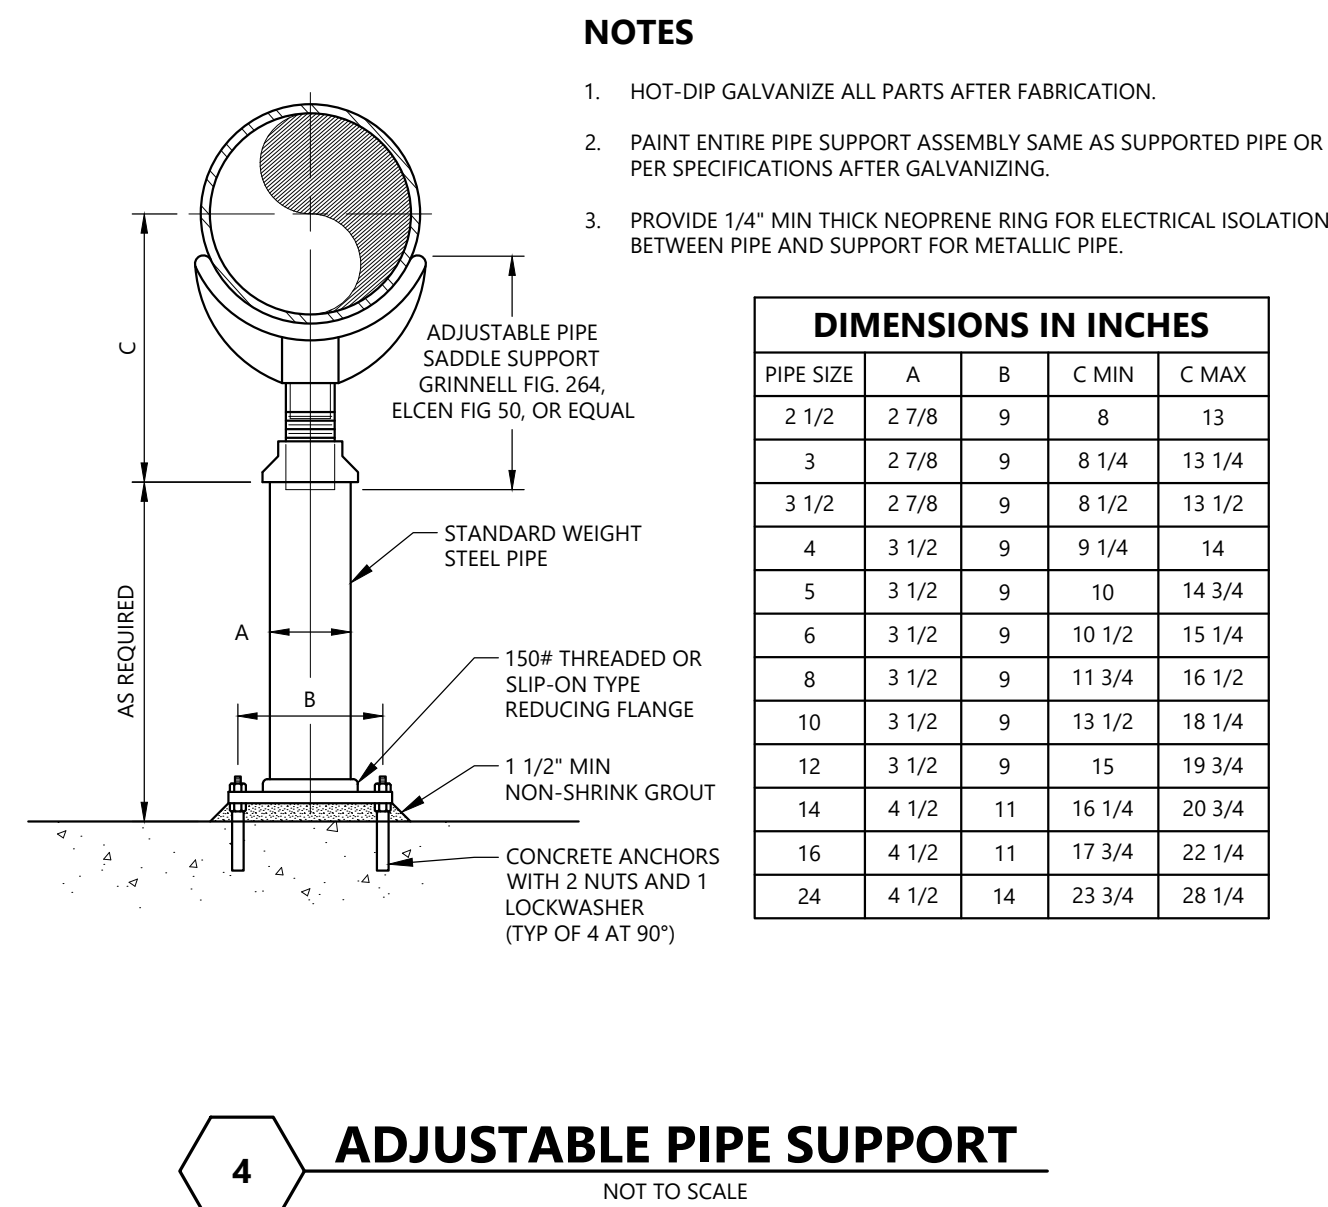
4 **ADJUSTABLE PIPE SUPPORT**  
NOT TO SCALE

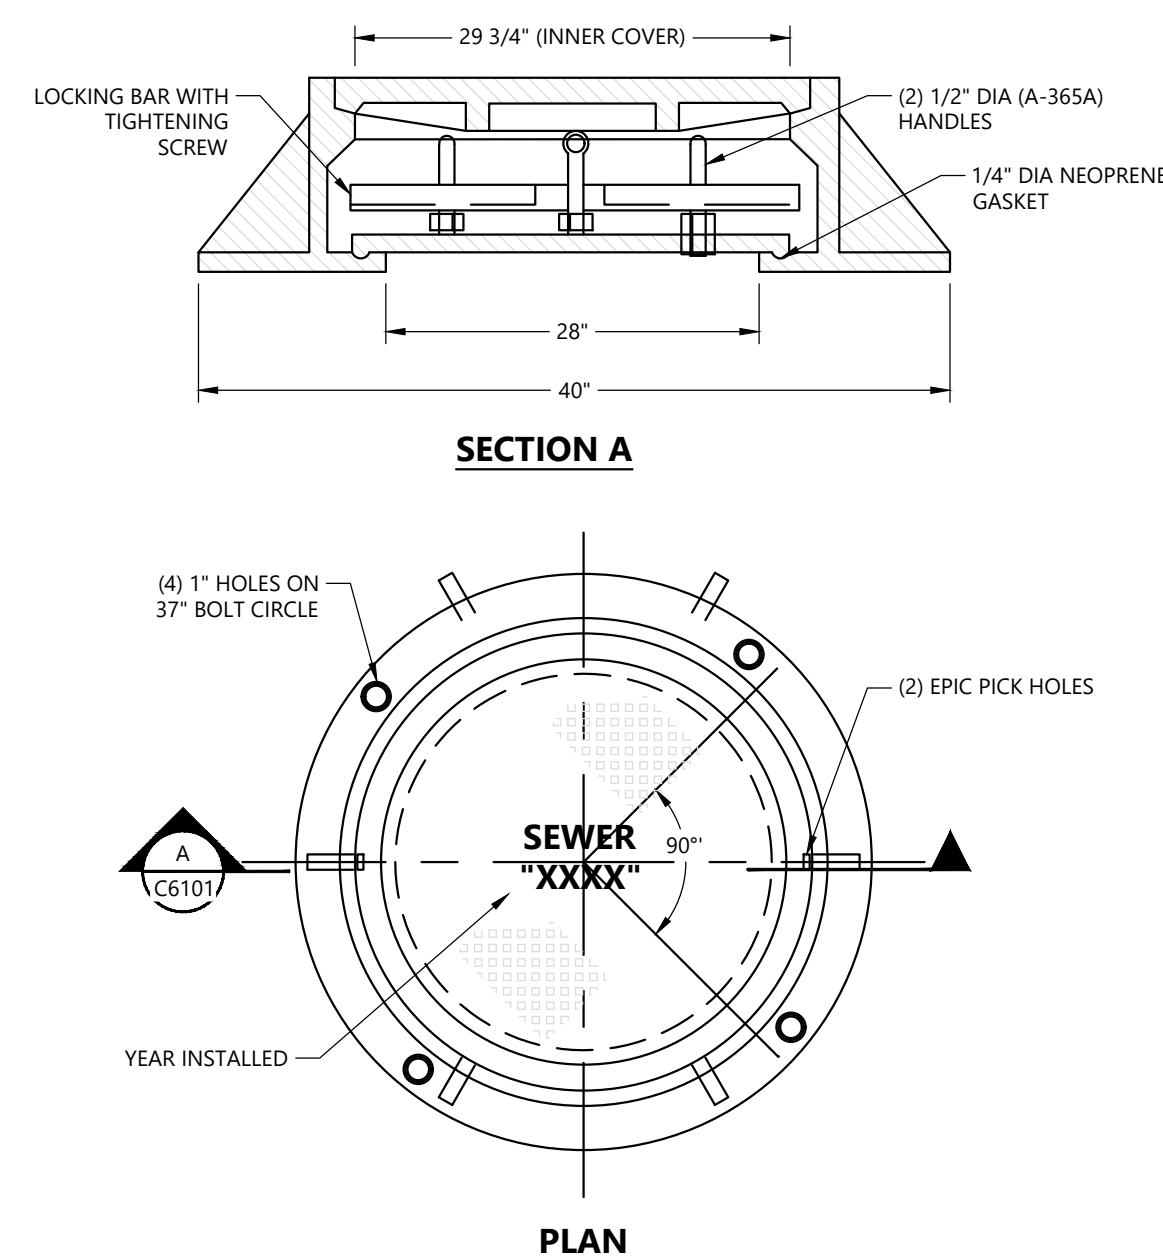
5 **BOLT-DOWN FRAME FASTENING**  
NOT TO SCALE

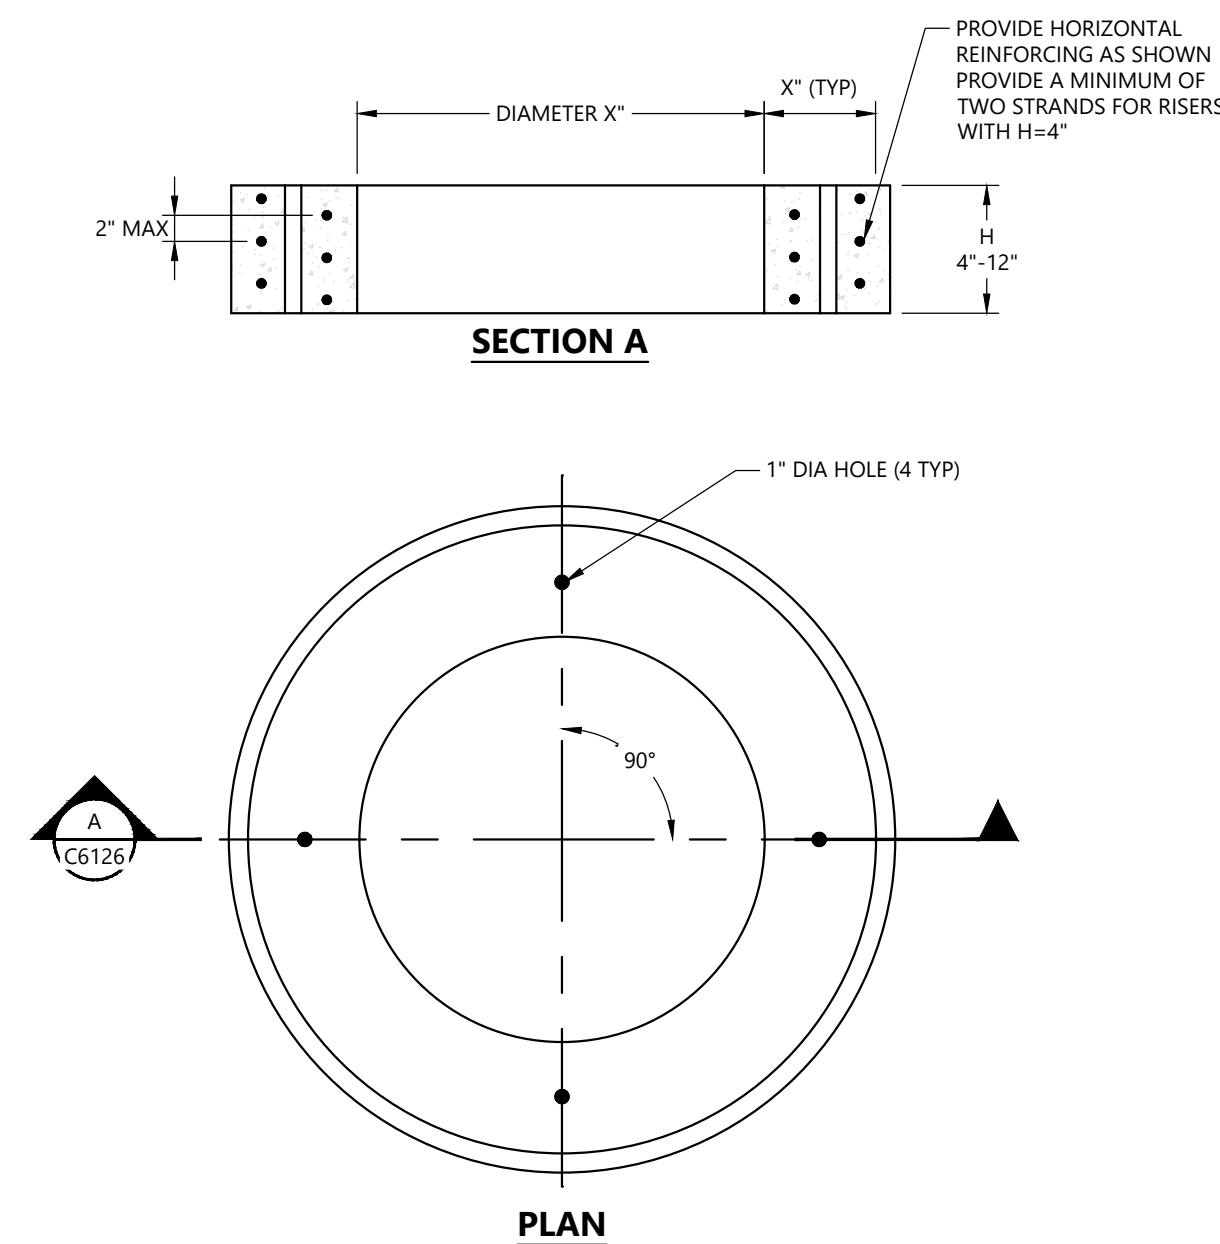
7 **PRE-CAST CONCRETE GRADE RING**  
NOT TO SCALE

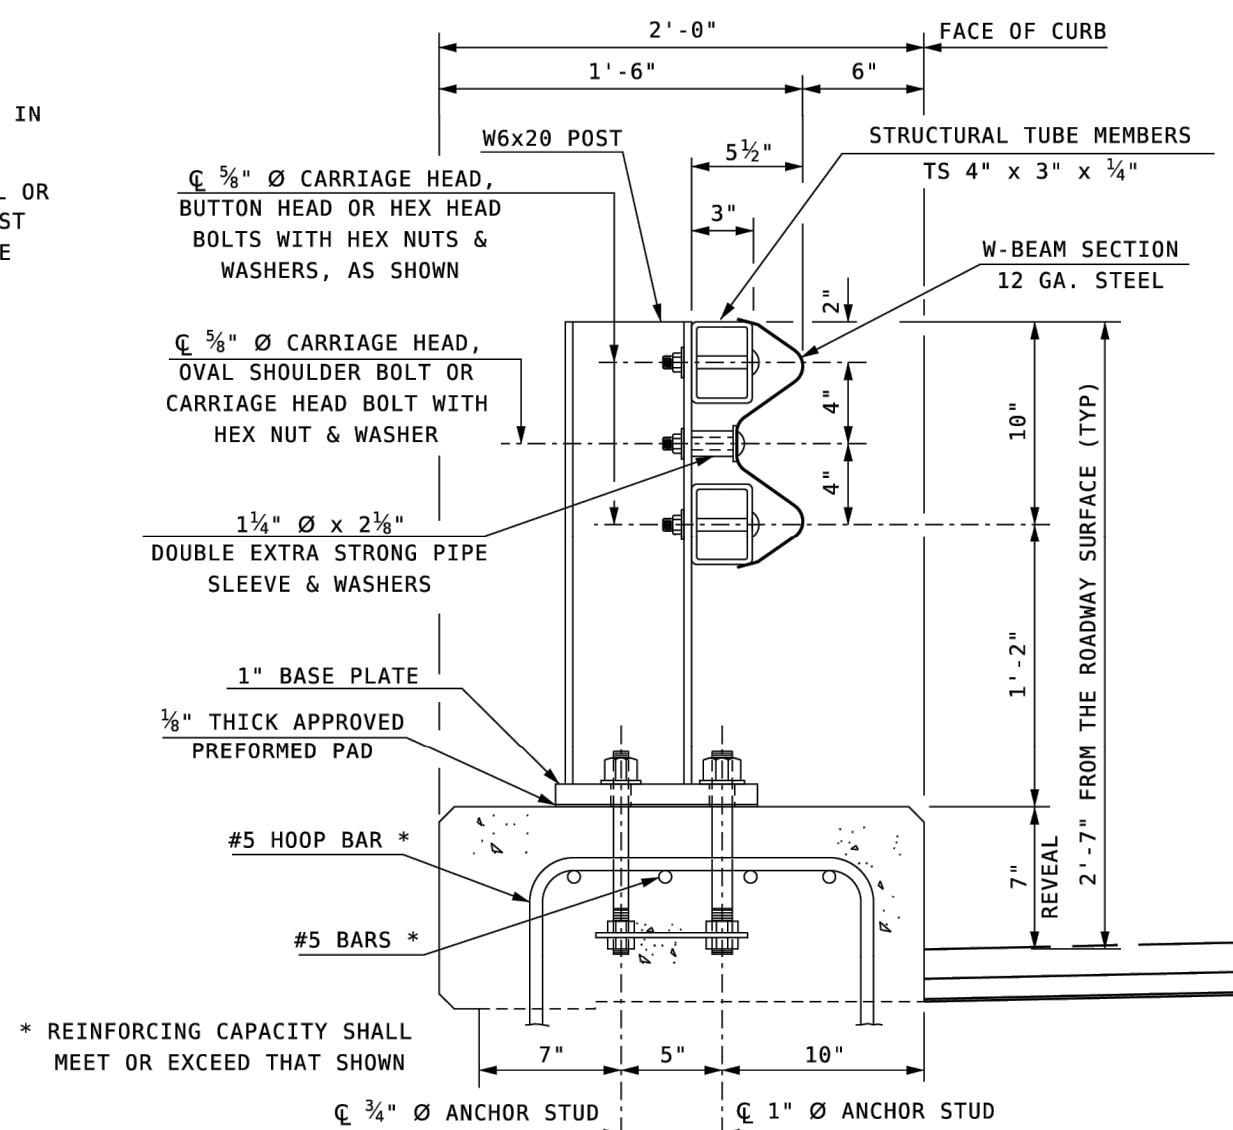
BRIDGE RAIL DETAIL

- (6) EACH PIECE OF RAIL TUBING SHALL BE ATTACHED TO A MINIMUM OF THREE POSTS.
- (7) FOR BRIDGE RAIL POST SPACING, SEE BRIDGE RAIL LAYOUT. THE MAXIMUM BRIDGE RAIL POST SPACING SHALL BE 8'-4". POST SPACING OF 8'-4" OR 6'-3" IS RECOMMENDED WHENEVER POSSIBLE FOR USE WITH 25' SECTIONS OF STANDARD W-BEAM RAIL.

- (11) MEMBERS TO BE PAINTED SHALL FIRST BE GALVANIZED AFTER FABRICATION IN CONFORMANCE WITH AASHTO M111 (ASTM A123) AND THEN OUTSIDE SURFACES SHALL BE SHOP PAINTED WITH ONE COAT OF 708 NH 3.81, ALIPHATIC POLYURETHANE (1.5 TO 2.5 MILS DFT, DARK BROWN (REFER TO SPECIAL PROVISIONS FOR SECTION 550 FOR PAINT SPECIFICATIONS). EXPOSED ANCHOR BOLTS, NUTS, WASHERS & RAIL BOLTS SHALL BE PAINTED DARK BROWN IN THE FIELD WITH NH 3.81.

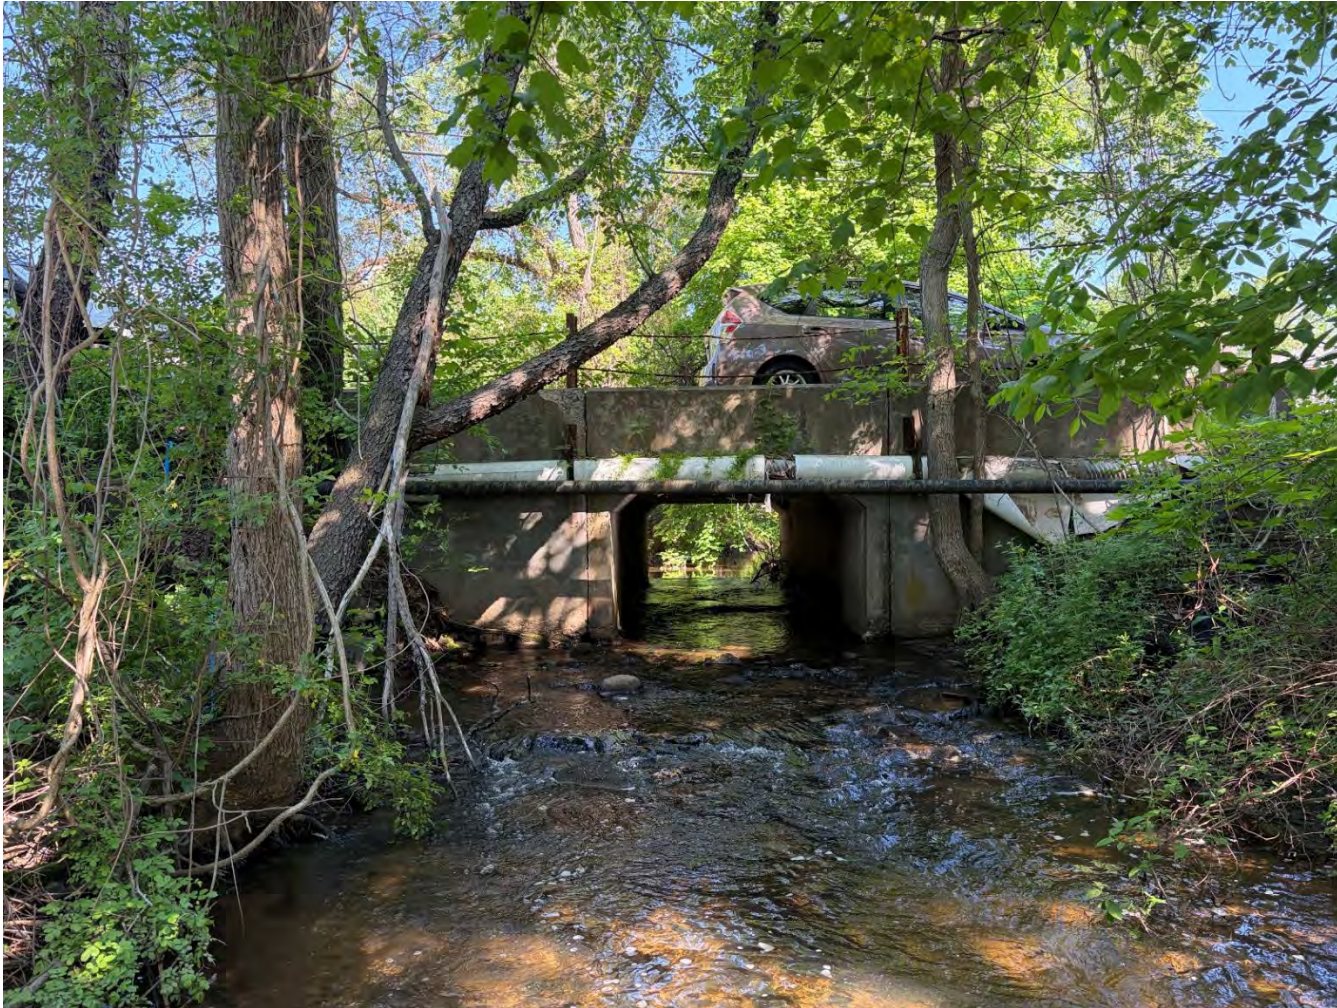
**Photo 2. Northerly view of Three Mile Brook and culvert on south side of Adams Street.**

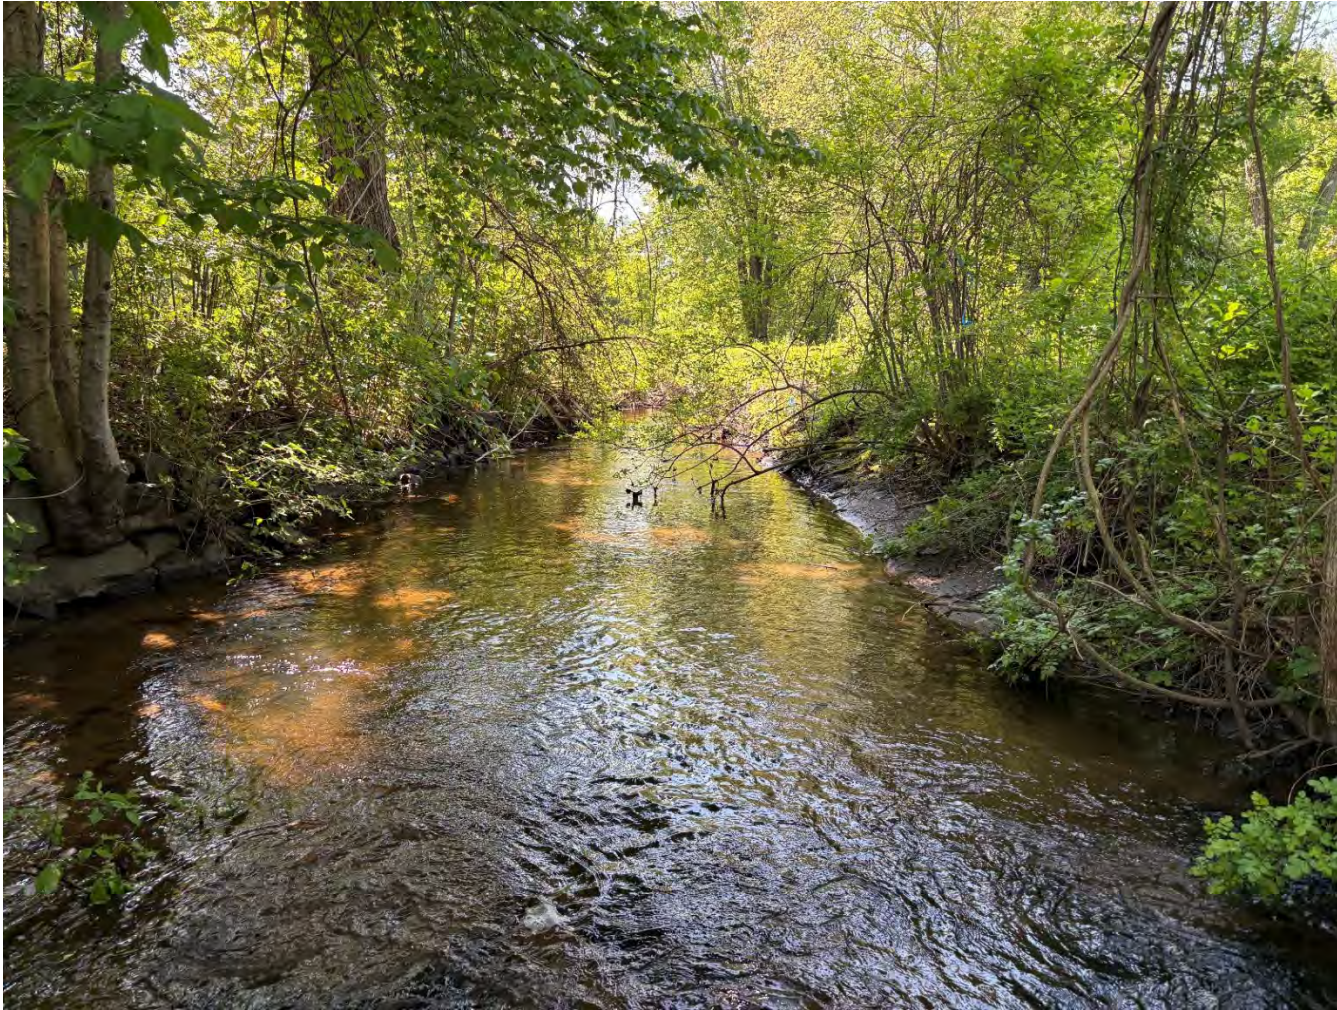
**Photo 5. Southerly view of Three Mile Brook immediately downstream of culvert. Placed rip rap on lower east Bank (left).**
